Visual Property Inspection Report

Complies with Australian Standard AS 4349.1-2007 & 4349.3

Sample Street

VISUAL BUILDING INSPECTION REPORT

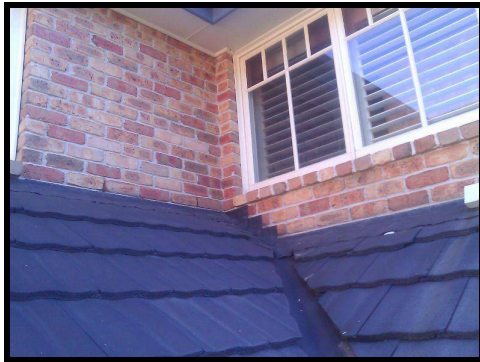
Flashing material is of lead. Flashing is split, in poor condition and will require rectification to the following areas; Junction of the pitched roof/s and wall. Recommend the installation of a soaker or apron flashing to roof junction/s. Failure to install these flashings may cause water entry and damage to property. These flashings should be installed to comply with Standards.

Estimated cost from: \$750.

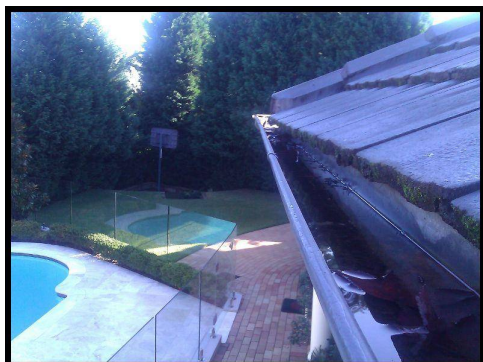
Downpipes are damaged or rusting and should be repaired or replaced as necessary. Water is ponding in the gutters and they require realigning. Guttering joints are leaking and repairs/maintenance required. Downpipes appear to be connected to the stormwater dispersal system, however, correct connection can only be confirmed with a smoke test.

Estimated cost from: \$1000.

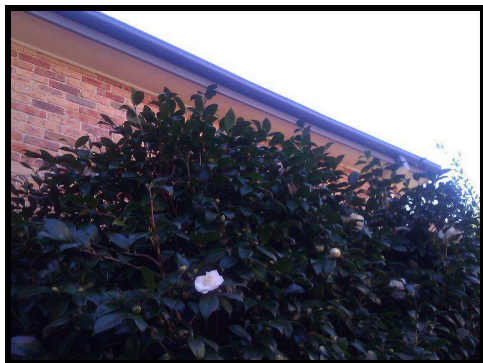
Inspection to sections of the exterior was restricted due to the growth of foliage. Foliage must be removed to enable a more complete report to be submitted. Inspection to sections of the exterior was restricted due to the stored goods. These goods must be removed to enable a more complete report to be submitted. Western of the structure. Inspection to the following fencing timbers was restricted in part by foliage - Right hand side fence.

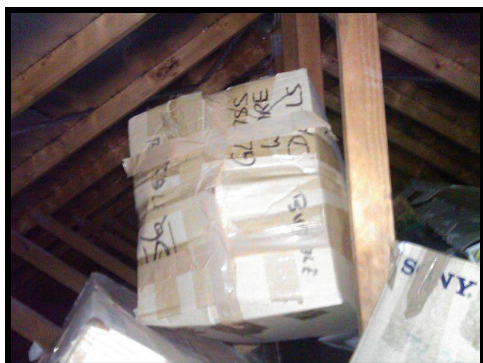
Sarking paper and insulation is present in the roof cavity. This restricted inspection to some roofing timbers. Removal of insulation is not within the scope of a standard visual building inspection report. Lining material has been placed over some ceiling timbers for storage purposes which prevented inspection of those covered timbers. Stored goods restricted inspection within this area. Inspection was restricted above the following locations and or areas: Garage.

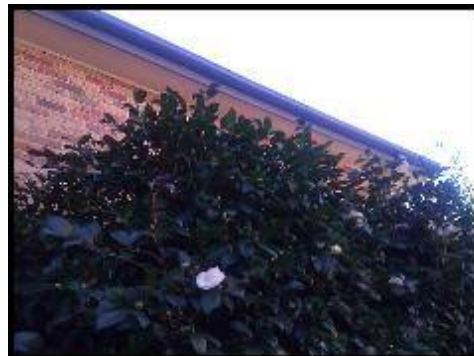
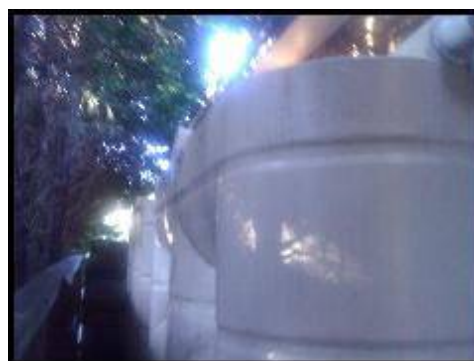
Restrictions: Inspection to sections of the exterior was restricted due to the growth of foliage. Foliage must be removed to enable a more complete report to be submitted. Inspection to sections of the exterior was restricted due to the stored goods. These goods must be removed to enable a more complete report to be submitted. Western of the structure. Inspection to the following fencing timbers was restricted in part by foliage - Right hand side fence.

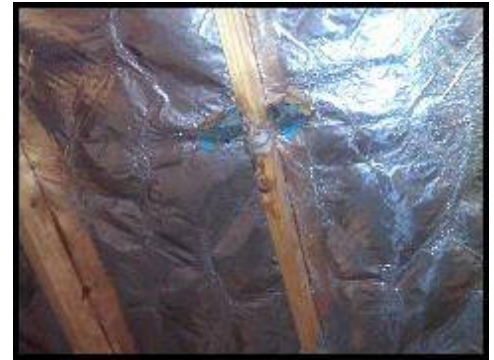
A small number of cracked roof tiles were noted and should be replaced. Mortar beds to the hip and ridge capping are cracked and require maintenance or re bedding and pointing in areas. Roof and/or flashings are allowing water to penetrate the interior of the building. Concealed internal roofing members may be damaged and require repair or replacement. This should be investigated further by a licensed contractor and rectified.

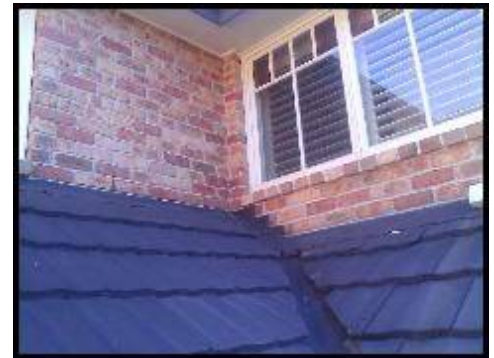
Flashing material is of lead. Flashing is split, in poor condition and will require rectification to the following areas; Junction of the pitched roof/s and wall. Recommend the installation of a soaker or apron flashing to roof junction/s. Failure to install these flashings may cause water entry and damage to property. These flashings should be installed to comply with Standards.

Estimated cost from: \$750.

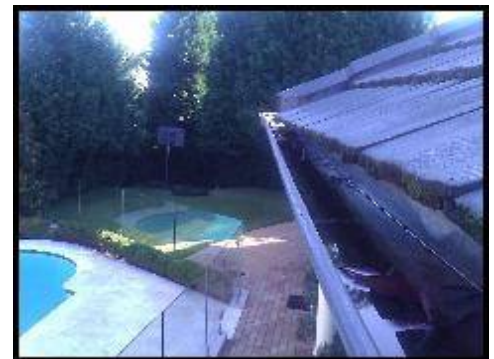
Downpipes are damaged or rusting and should be repaired or replaced as necessary. Water is ponding in the gutters and they require realigning. Guttering joints are leaking and repairs/maintenance required. Downpipes appear to be connected to the stormwater dispersal system, however, correct connection can only be confirmed with a smoke test.

Estimated cost from: \$1000.

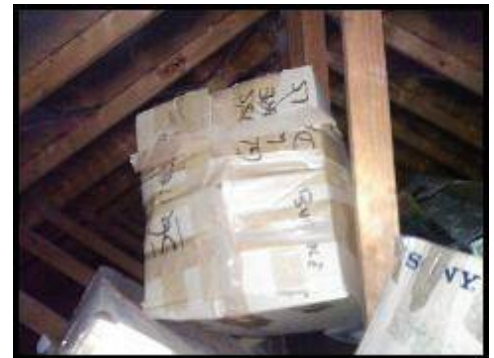
Restrictions: Sarking paper and insulation is present in the roof cavity. This restricted inspection to some roofing timbers. Removal of insulation is not within the scope of a standard visual building inspection report. Lining material has been placed over some ceiling timbers for storage purposes which prevented inspection of those covered timbers. Stored goods restricted inspection within this area. Inspection was restricted above the following locations and or areas: Garage.

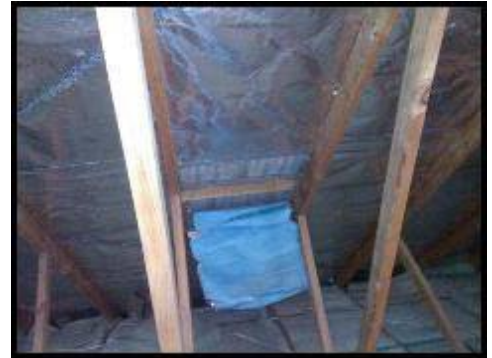
Sarking Status: Sarking has been provided to the roof area. Sarking is present but is torn or has holes in some areas. This may affect the waterproofing ability of the sarking and damaged areas should be considered for repair.

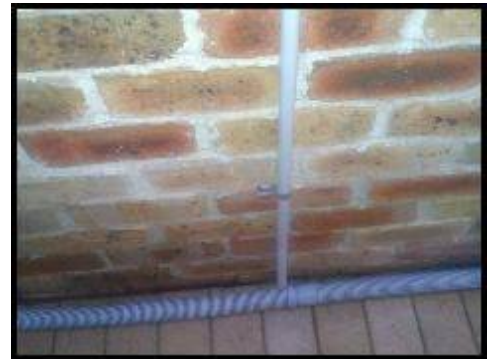
Details: Gas is connected to the premises, however, has not been evaluated and should be inspected by a qualified gas fitter. Water tank/s present, however, has not been evaluated and should be inspected by a qualified plumber. Smoke detectors are fitted, however, the positioning, operation or adequacy was not tested and is not commented on. An earth leakage circuit breaker (safety switch) appears to be installed to the electrical switch board. Positioning, operation or adequacy was not tested. The evaluation of air-conditioning is not part of a standard pre purchaser building inspection report and is the subject of a special purpose report. We recommend this be carried out by a specialist in air-conditioning installation, maintenance and control. Air-conditioning condensation discharge pipe should be diverted away from the external walls. Damp soil around the building may cause swelling and lead to heaving of structure and cracking to walls. Moisture also encourages termites into the area. We strongly recommend this pipe be connected to a drainage point. An alarm system is present, however, the operation or adequacy was not tested.

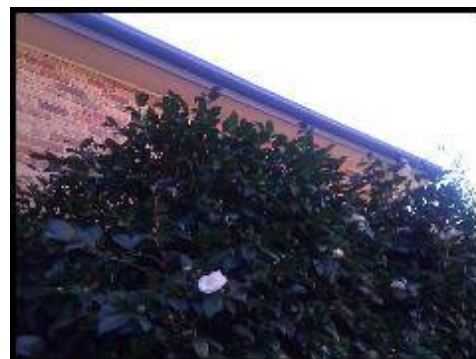
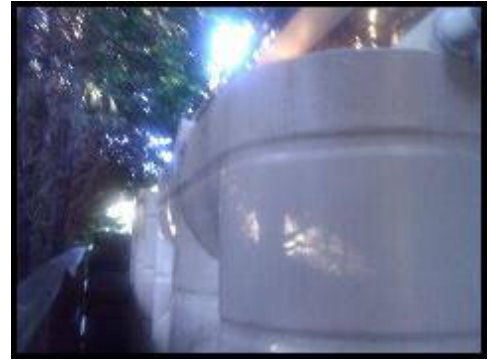
Inspection to sections of the exterior was restricted due to the growth of foliage. Foliage must be removed to enable a more complete report to be submitted. Inspection to sections of the exterior was restricted due to the stored goods. These goods must be removed to enable a more complete report to be submitted. Western of the structure. Inspection to the following fencing timbers was restricted in part by foliage - Right hand side fence.

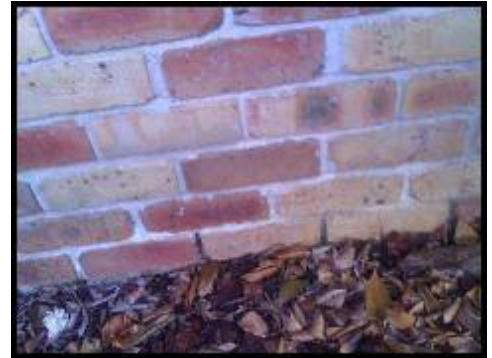
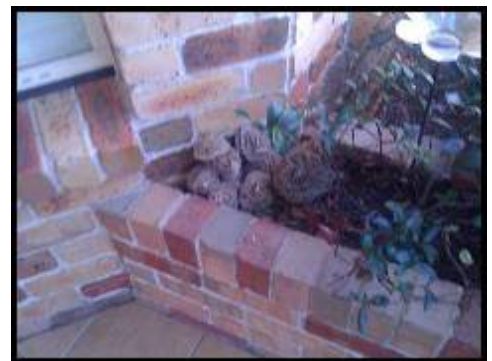
The air-conditioning condenser discharges adjacent to the external walls. We recommend modification so that water is discharged over a drain. The fence or fence posts are in direct contact with the building structure. This situation can allow termites to enter the structure and we recommend that suitable modifications be made so that fencing timbers are not in direct contact with the structure. The external vents/weep holes are either covered completely or partly concealed. This can allow concealed termite entry and we recommend that all vents/weep holes be exposed and kept clear of soil, foliage, debris, stored items or other obstructions. Some gutters and/or downpipes appear to discharge rainwater directly adjacent to the foundations of the structure. These should be connected to a stormwater dispersal system. The level of some external paths, paved areas or soil is either higher than, or at a similar level, as that of the internal floors. This situation could allow concealed termite entry. We strongly recommend the lowering of these to below the internal floor level to reduce the risk of concealed termite entry. Garden beds have been built up against the external walls. These should be removed as they can allow concealed termite entry.

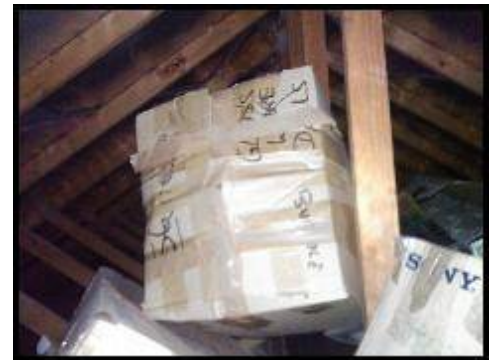
Sarking paper and insulation is present in the roof cavity. This restricted inspection to some roofing timbers. Removal of insulation is not within the scope of a standard visual building inspection report. Lining material has been placed over some ceiling timbers for storage purposes which prevented inspection of those covered timbers. Stored goods restricted inspection within this area. Inspection was restricted above the following locations and or areas: Garage.
