Visual Property Inspection Report

Complies with Australian Standard AS 4349.1-2007

Sample Street

VISUAL BUILDING INSPECTION REPORT

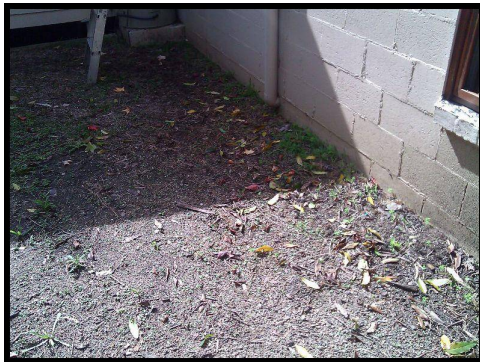
The surface water drainage at the rear of the property appears to be inadequate. Drains should be installed to divert seepage and surface runoff water away from the building to prevent possible structural damage. The drains should be connected to the existing stormwater drainage system.

Estimated cost from: \$1500.

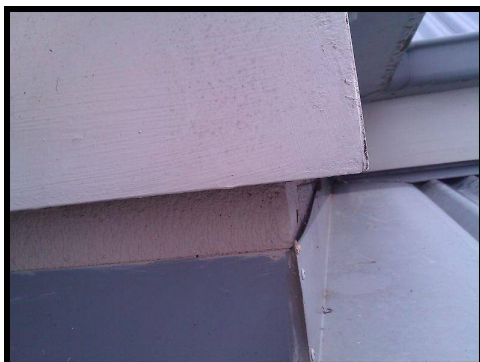
Flashing material is of preformed aluminium. Junction of the pitched roof/s and wall. Gable/s. Flashing is not or does not appear to be correctly set into the brickwork. This can allow water penetration and should be rectified. Potential water leak noted. Repair to the flashings should be considered. This area should be monitored and if leaking or damage is evident, referred to roofing experts for their assessment.

Estimated cost from: \$750.

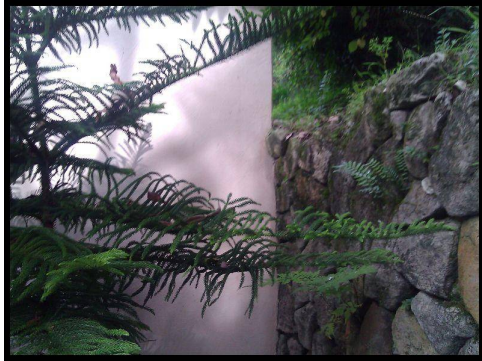
The ground levels are close or covering the damp proof course material and should be lowered to prevent dampness problems. The height of a DPC, or flashing serving as a DPC is recommended be not less than 150 mm above the adjacent ground level, 75 mm above the finished surface level of adjacent paved, concrete or landscaped areas that slope away from the wall or 50 mm above finished paved, concrete or hard landscaped areas. Base of some walls are below the external soil levels are be subject to lateral dampness or water entry. Additional waterproofing will be required or modifications will need to be made to lower moisture levels.

Estimated cost from: \$5000.

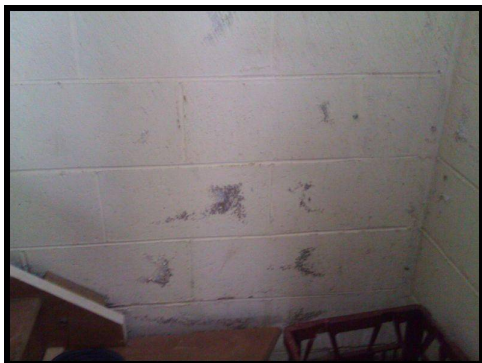
Walls to the area are moist and this may be the result of a plumbing leak, rising or lateral dampness. Recommend further invasive investigation be conducted to determine the cause of the moist area.

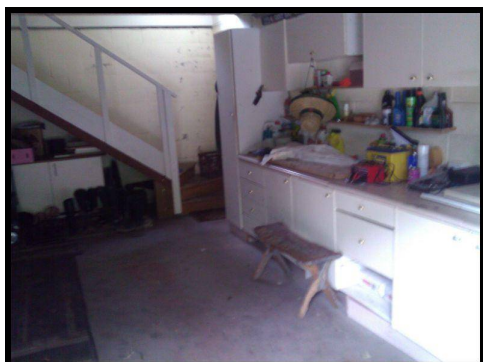
Stored items restricted inspection to the interior. These goods must be removed to enable a more complete report to be submitted. The structure is partially lined preventing inspection to some framing timbers.

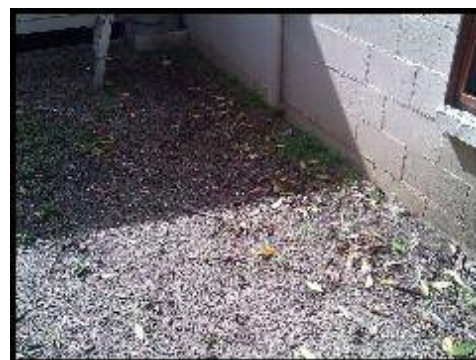
Surface Water: The surface water drainage at the rear of the property appears to be inadequate. Drains should be installed to divert seepage and surface runoff water away from the building to prevent possible structural damage. The drains should be connected to the existing stormwater drainage system.

Estimated cost from: \$1500.

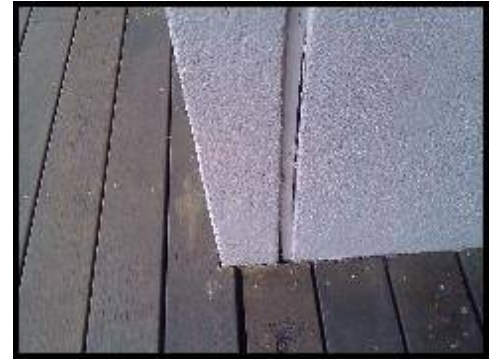
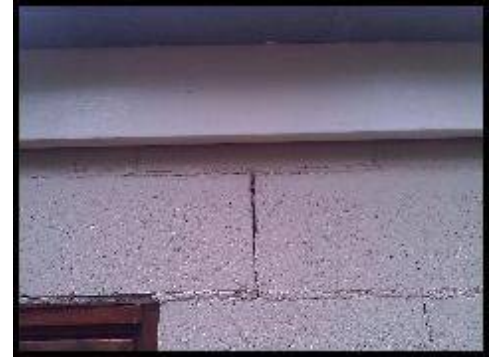
Northern elevation. Eastern elevation. Southern elevation.

Mortar joints between brickwork are deteriorating and require re pointing in areas. Shrinkage cracks are evident to rendered wall areas. This cracking generally occurs during the curing process of construction. Cracking of this type is an appearance defect and is not considered to be of a structural nature. Some repairs may be required prior to next painting to provide a suitable finish. Expansion joints to the brickwork are showing movement and require maintenance.

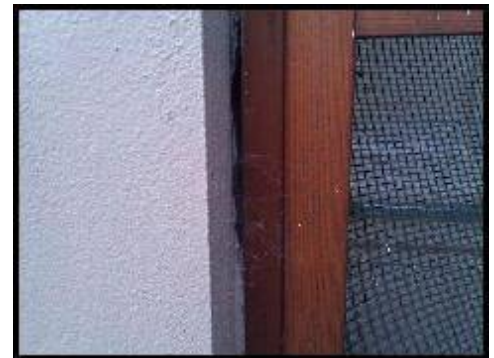
Storm moulds are not present and need to be fitted to ensure water does not penetrate wall cavity. Rectification is required. Minor maintenance and or repairs are required prior to next repainting.

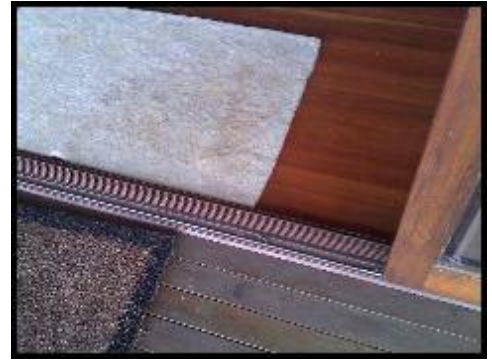
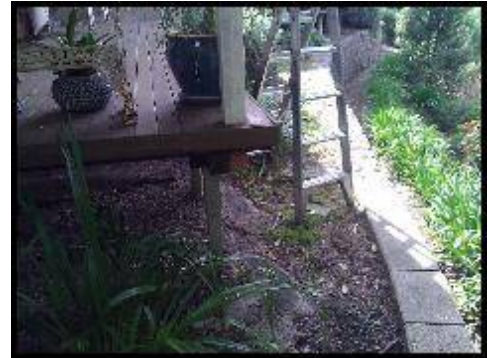
Position/Location:	Eastern elevation.
Construction & Condition:	Constructed from timber.
Defects Or Maintenance Items:	The area has a drop greater than 1 metre from the floor and a balustrade should be installed to comply with Standards. There is no step down between external and internal floors. This situation will allow wind driven rain to penetrate from the exterior of the building. Lack of suitable stepdown may be considered a latent defect. Timber flooring is loose and requires re fixing.

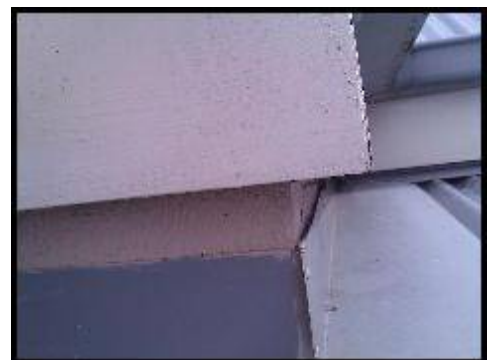
Roof Style:	The roof is of pitched and skillion construction.
Roof Access Limitations:	The roofing materials were viewed from a distance only. It should be noted that when roofing cannot be inspected in detail, other associated aspects of the roofing are also often not inspected in detail. These may include items such as gutters, eaves, flashings, chimneys and other items that would require a detailed and close inspection of the roof surface.
Position/Location:	Northern elevation.
Roof Covering Condition Detail:	The overall condition of the roof coverings is fair.
Roof Flashing - Type And Condition:	Flashing material is of preformed aluminium. Junction of the pitched roof/s and wall. Gable/s. Flashing is not or does not appear to be correctly set into the brickwork. This can allow water penetration and should be rectified. Potential water leak noted. Repair to the flashings should be considered. This area should be monitored and if leaking or damage is evident, referred to roofing experts for their assessment.

Estimated cost from: \$750.

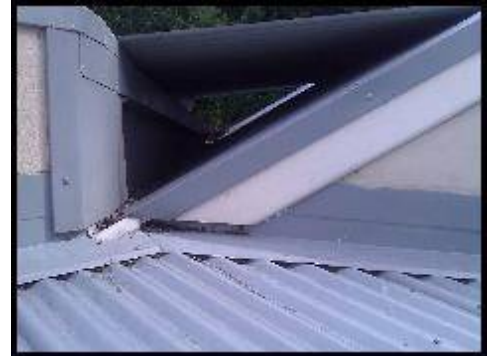
Leaves and debris are present in gutters and the guttering should be cleared. Downpipes appear to be connected to the stormwater dispersal system, however, correct connection can only be confirmed with a smoke test. Leaf guards are present to guttering and or valleys restricting inspection of these areas. Defects may be present and not detected. The design and position of the guttering is such that during wet conditions it appears that the gutter may back flow into the eave or building. Recommend the area be evaluated during wet conditions. Some modifications may be required. The roof area has a boxed gutter installed that is located above an internal section of the building. These type of gutters require regular maintenance to keep clear and prevent overflow. Any leaking, from overflow, poor joints or damage, will allow water to enter the building. Recommend this area be closely monitored for water entry.

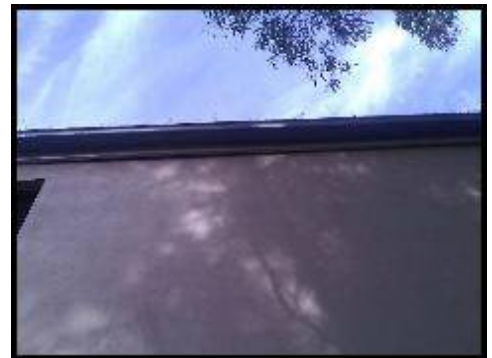
The eaves appear to be lined with fibre cement sheeting. The overall condition of the eaves lining is fair. Parts of this building does not have an eave overhang and as such may be subject to water entry if the guttering backflows during wet conditions. Recommend this area be closely monitored.

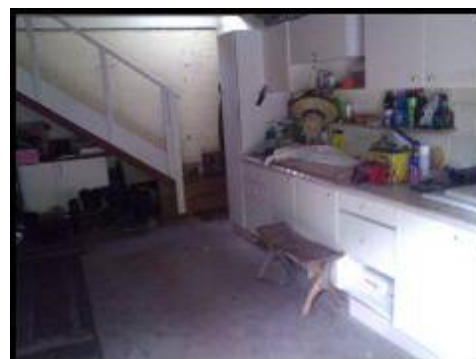
Restrictions: Stored items restricted inspection to the interior. These goods must be removed to enable a more complete report to be submitted. The structure is partially lined preventing inspection to some framing timbers.

Defects and or damage requiring rectification may not be apparent to the inspector due to this restriction. Recommend access be gained.

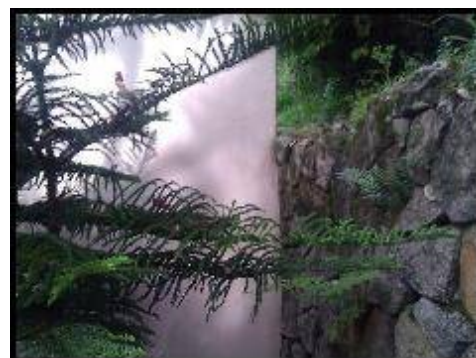
Position/Location: Eastern elevation. Southern elevation. Western elevation.

Wall Condition: The ground levels are close or covering the damp proof course material and should be lowered to prevent dampness problems. The height of a DPC, or flashing serving as a DPC is recommended be not less than 150 mm above the adjacent ground level, 75 mm above the finished surface level of adjacent paved, concrete or landscaped areas that slope away from the wall or 50 mm above finished paved, concrete or hard landscaped areas. Base of some walls are below the external soil levels are be subject to lateral dampness or water entry. Additional waterproofing will be required or modifications will need to be made to lower moisture levels.

Estimated cost from: \$5000.

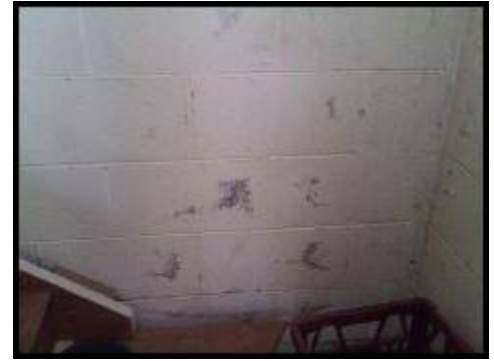
Internal Walls Condition: Walls to the area are moist and this may be the result of a plumbing leak, rising or lateral dampness. Recommend further invasive investigation be conducted to determine the cause of the moist area.

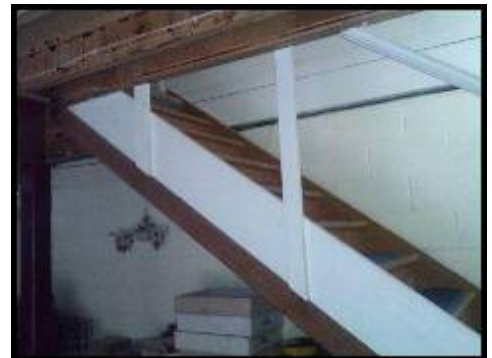
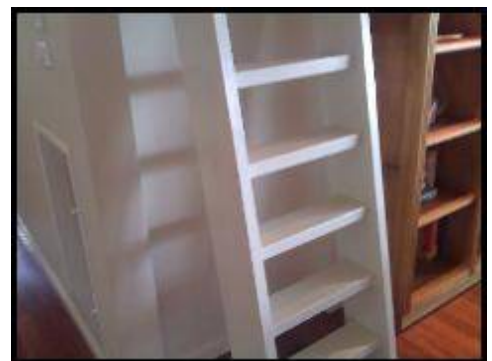
Stairs Condition: The stairs are constructed primarily from timber. The handrails and balustrades do not comply with Standards for height and or spacing. Recommend they be updated. Rise and going (height & depth) of treads is hazardous and does not comply with current Standards. Recommend these areas be modified.

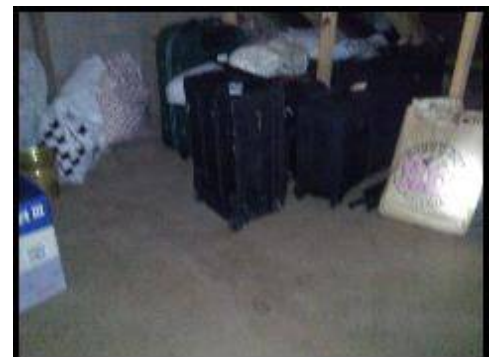
Restrictions: Sarking membrane covered tile battens restricting inspection. Lining material has been placed over some ceiling timbers for storage purposes which prevented inspection of those covered timbers. Stored goods restricted inspection within this area. Inspection was restricted above the following locations and or areas: Bathroom. Garage.

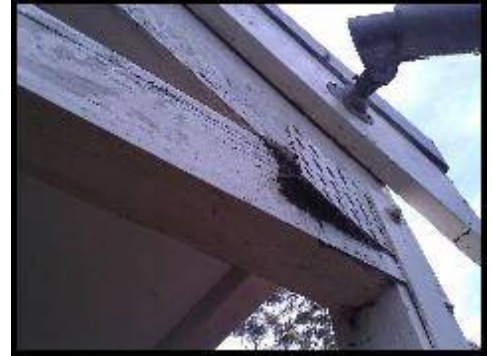
Roof trusses have been damaged and do not appear to be structurally adequate. A roof truss is a structural element of the roof frame and if altered or damaged can have adversely affecting the roof structurally. Repair or replacement of the roof truss will be required. A structural engineer should be engaged to provide an opinion as to the structural adequacy of the roof support system and repairs.

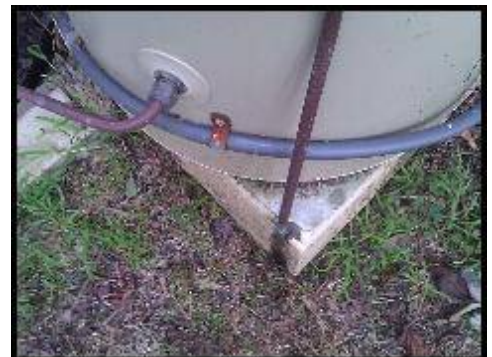
Mains electric hot water system: Mains pressure: Located externally: The hot water system appears to be in working condition. No specific tests other than running the hot water tap were carried out. No determination has been made as to the suitability or adequacy of the hot water system in relation to capacity or otherwise. Hot water overflow pipe should be diverted away from the external walls. Damp soil around the building may cause swelling and lead to heaving of structure and cracking to walls. Moisture also encourages termites into the area. We strongly recommend the overflow relief valve be connected to a drainage point.
