Visual Property Inspection Report

Complies with Australian Standard AS 4349.1-2007

Sample Street

VISUAL BUILDING INSPECTION REPORT

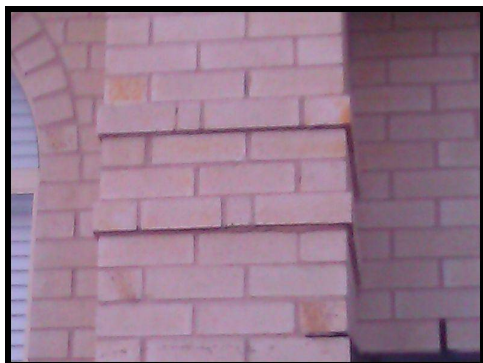
The ground levels are close or covering the damp proof course material and should be lowered to prevent dampness problems. The height of a DPC, or flashing serving as a DPC is recommended be not less than 150 mm above the adjacent ground level, 75 mm above the finished surface level of adjacent paved, concrete or landscaped areas that slope away from the wall or 50 mm above finished paved, concrete or hard landscaped areas.

Mortar joints between brickwork have not been ironed correctly and are inconsistent with the rest of the building (corbel course above front entry, behind downpipe of garage)

Brickwork is discoloured in areas or has been poorly blended and recommend an expert from the brick supplier be requested to provide a further evaluation.

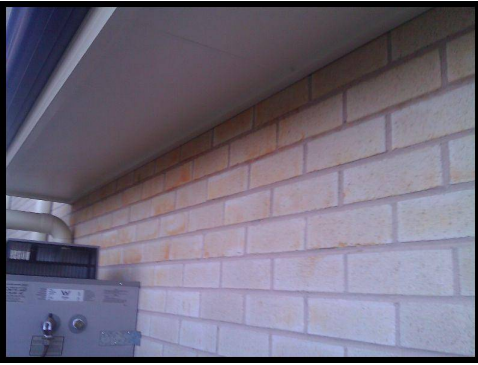
Northern elevation. Eastern elevation. Western elevation.

Weep holes to the base of the brick walls are blocked or partly blocked by mortar and should be cleared to help prevent moisture and pest problems.

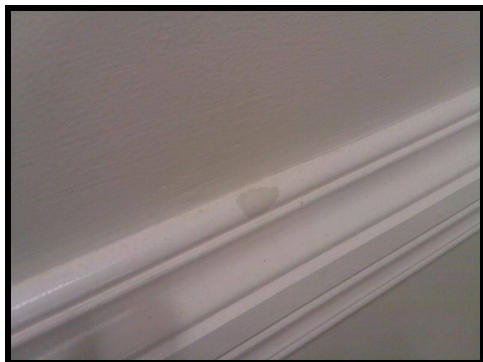
Painting is not complete, appears transparent and requires rectification to provide a suitable finish.

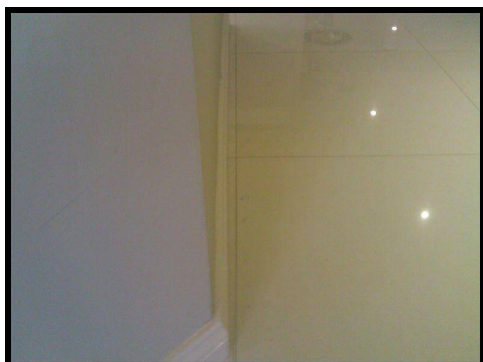
Poor joint setting was noted to some walls. Rectification will be required (toilet).

The sliding door/s are not plumb when in the closed position and require adjustment and or repair.

The quality of the tiling is poor to the bath hob area. Rectification will be required.

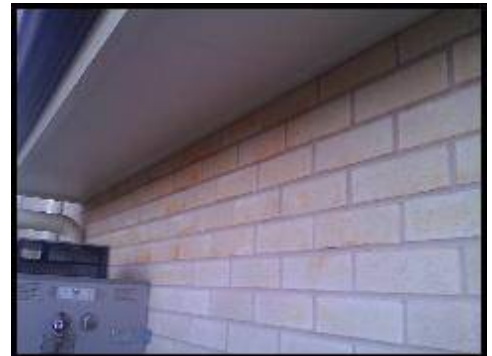
Northern elevation. Eastern elevation. Western elevation.

Mortar joints between brickwork have not been ironed correctly and are inconsistent with the rest of the building (corbel course above front entry, behind downpipe of garage)

Brickwork is discoloured in areas or has been poorly blended and recommend an expert from the brick supplier be requested to provide a further evaluation.

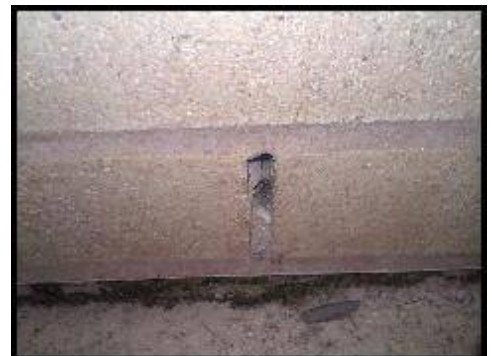
Weep holes to the base of the brick walls are blocked or partly blocked by mortar and should be cleared to help prevent moisture and pest problems.

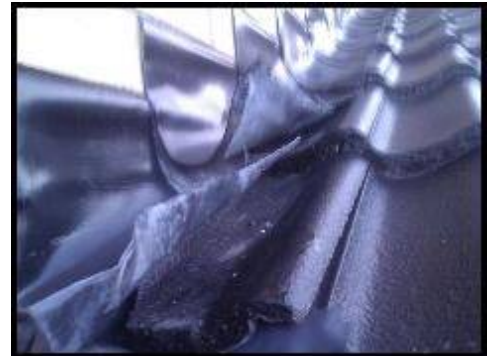
Roof Flashing - Type And Condition: Flashing material is of lead. Recommend the installation of a soaker or apron flashing to step flashings to prevent water entry and to comply with Standards. Rectification will be required.

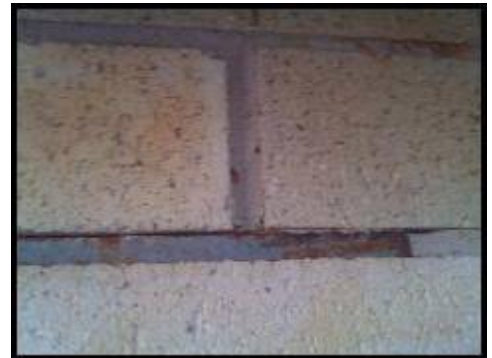
Lintels - Type & Condition: Lintel type/s noted: Mild steel. Rust is evident to some steel lintels. Rusted areas should be treated to prevent further deterioration.

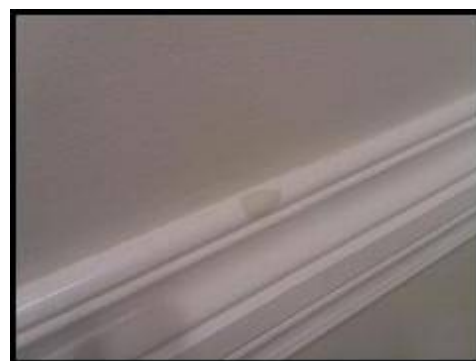
Internal Walls Condition: Painting is not complete, appears transparent and requires rectification to provide a suitable finish.

Woodwork: Painting is not complete, appears transparent and requires rectification to provide a suitable finish.

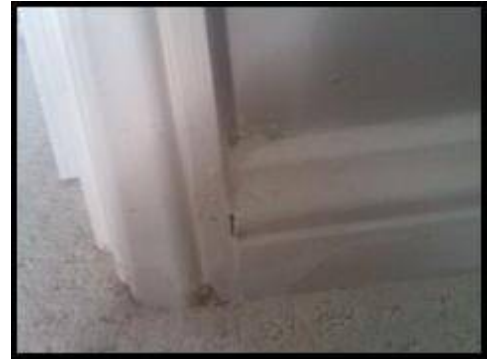
Internal Walls Condition: Settlement cracks are evident to wall areas. Rectification will be required.

Floors Condition: Flooring is uneven and squeaking flooring was noted. These areas should be leveled and secured to prevent movement.

The condition of the woodwork is generally poor. Rectification will be required.

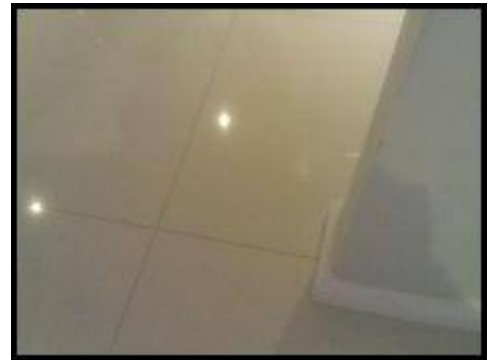
Cracking is present to cornices and these areas will require maintenance and or repair.

Walls have not been installed square/parallel with the tiling. Rectification will be required.

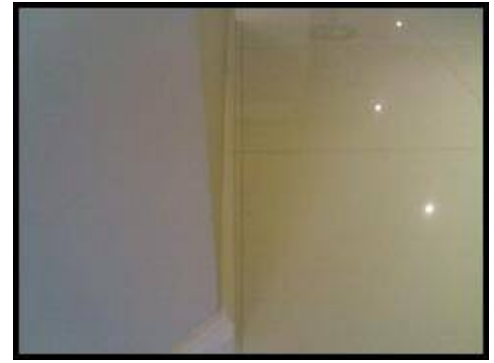
Internal Walls Condition: Painting is in poor condition and recommend repainting. Walls have not been installed square/parallel with the tiling. Rectification will be required.

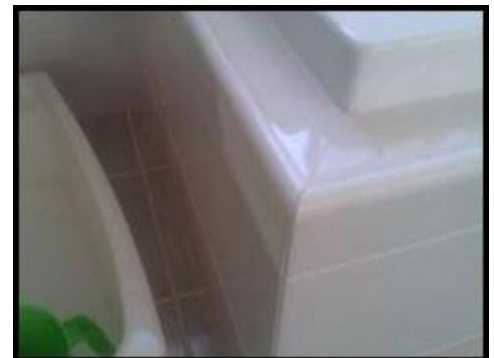
Tiles: The quality of the tiling is poor to the bath hob area. Rectification will be required.

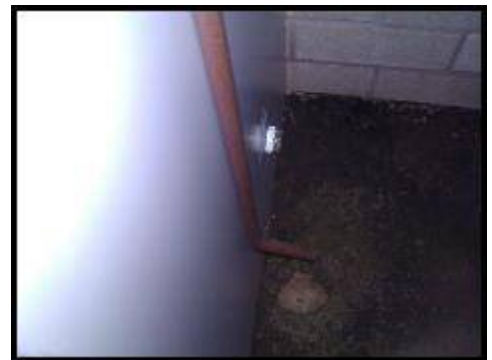
Type/Condition: Gas hot water system: Mains pressure: Located externally: The hot water system appears to be in working condition. No specific tests other than running the hot water tap were carried out. No determination has been made as to the suitability or adequacy of the hot water system in relation to capacity or otherwise. Hot water overflow pipe should be diverted away from the external walls. Damp soil around the building may cause swelling and lead to heaving of structure and cracking to walls. Moisture also encourages termites into the area. We strongly recommend the overflow relief valve be connected to a drainage point.
