Visual Timber Pest Inspection Report

Sample Street

Date Of Inspection: 17/05/2012.

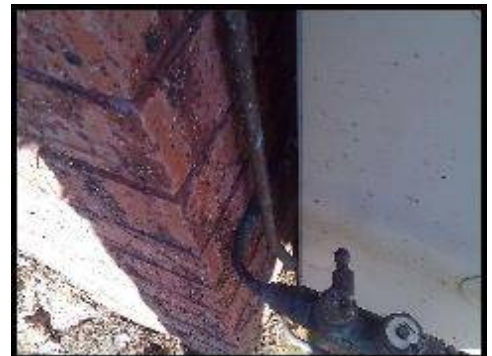
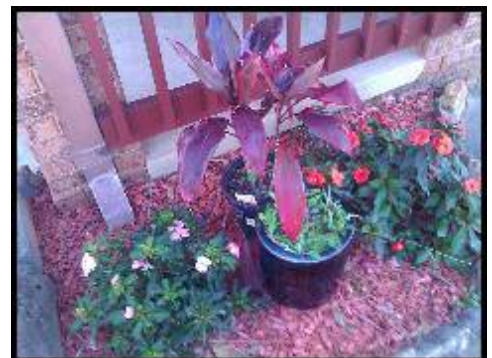
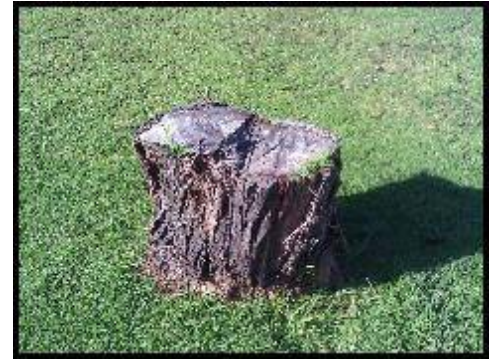
Description	The hot water system overflow is discharging moisture adjacent to the structure. We recommend the overflow be situated over a drain. Tree stumps should be removed.
--------------------	---

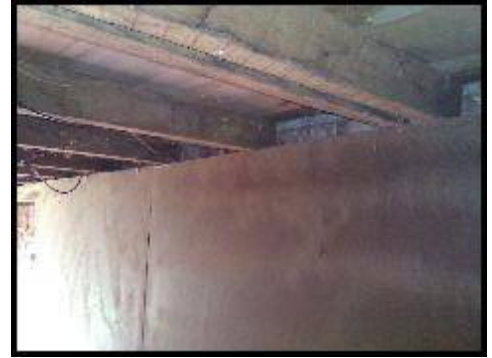
Inspection was restricted in or below the following locations and or areas: Toilet. Bedroom two. Bedroom three. Some or all of the original timbers have been covered by lining material.

Active termites or other timber damaging pests may be present and not detected in areas where inspection was limited, obstructed or access was not gained. We **STRONGLY** recommend that access be gained to all inaccessible areas. See Section 2.0 - Reasonable Access

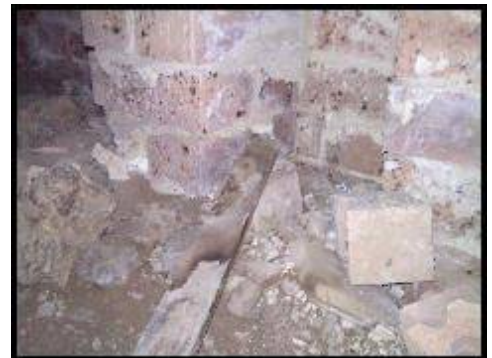
We recommend the removal of loose timbers from the underfloor area as these predispose the property to termite attack.

Below The Following Location Or Area; Isolated areas throughout.
