## **Visual Dilapidation Inspection Report**

Complies with Australian Standard AS 4349.1-2007

**Sample Street**

**Report Type:** Visual Dilapidation Building Inspection.

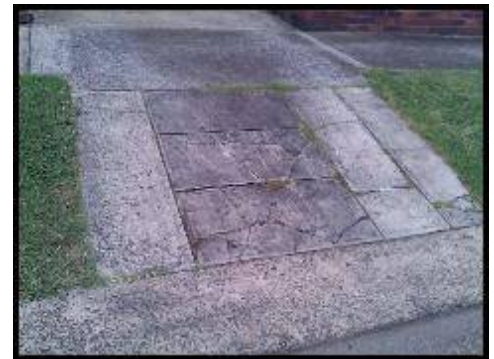
### Driveway:

Driveway has some minor cracking, also some minor subsidence at the street entrance.

Located; Driveway, Width; 1-2mm, Length; Various.

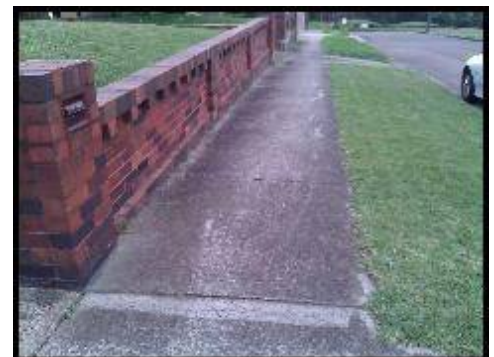
### Foot Path:

No apparent structural defects are noted to the footpath.

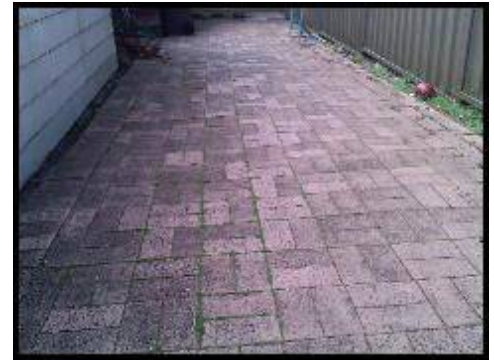
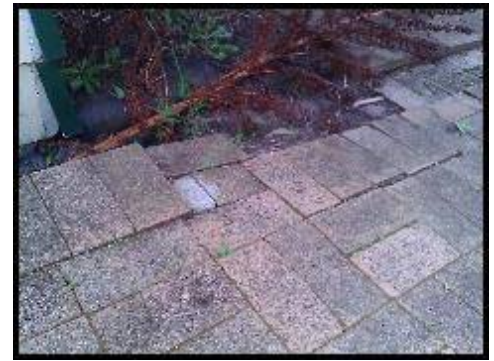
**Paths:**

Paved areas have subsided in various areas.

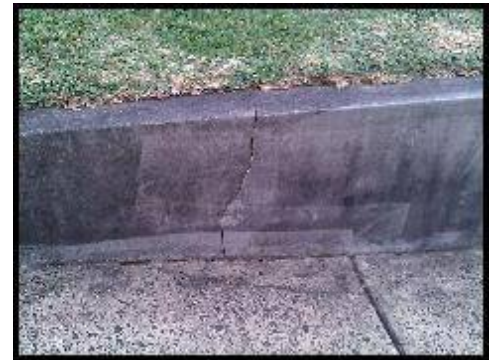
**Retaining Walls:**

Retaining wall has some minor cracking at the driveway area.

Located; Driveway Retaining Wall, Width; 2mm, Length; 500mm.

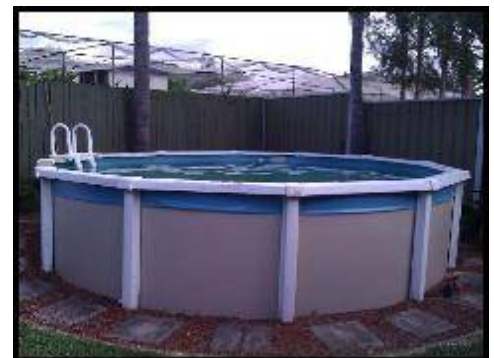
**Swimming Pool:**

No apparent structural defects are noted.

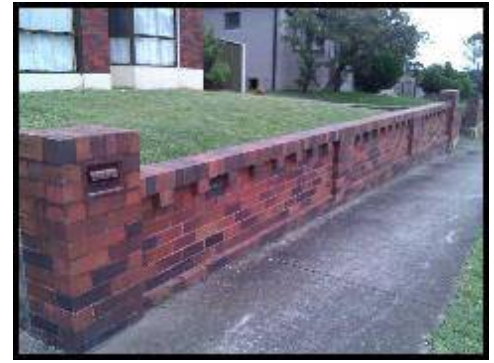
**Fencing:**

**Noted Defect:** No apparent structural defects are noted.

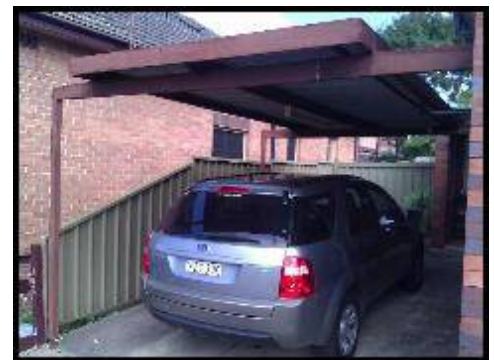
**Carpport:**

**Noted Defect:** No apparent structural defects are noted.

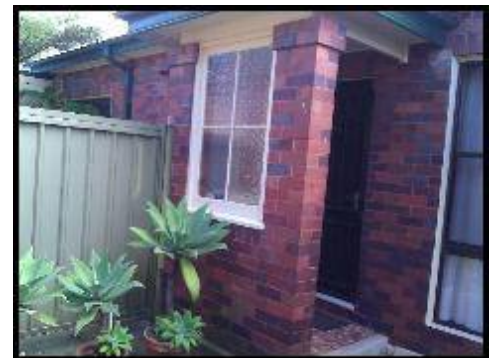
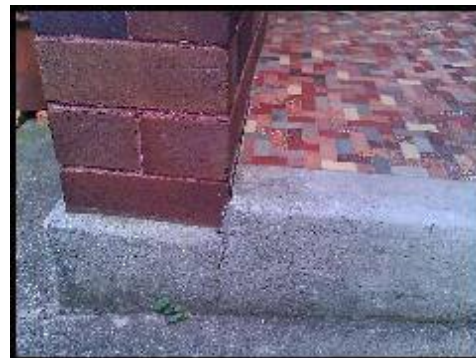
**Verandah:**

Minor cracking is noted to the concrete floor.

Located; Verandah, Width; 1-2mm, Length; 200mm.

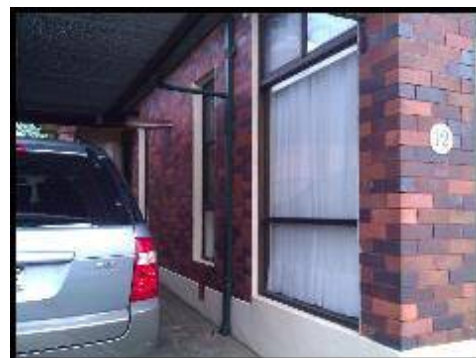
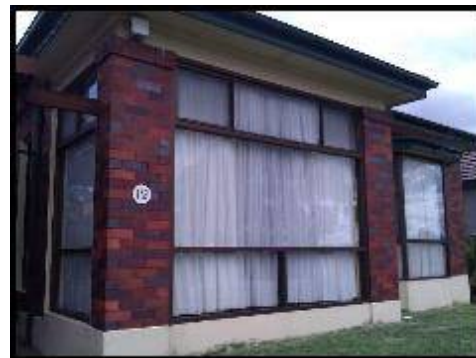
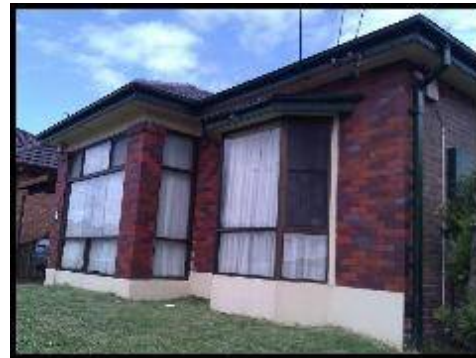
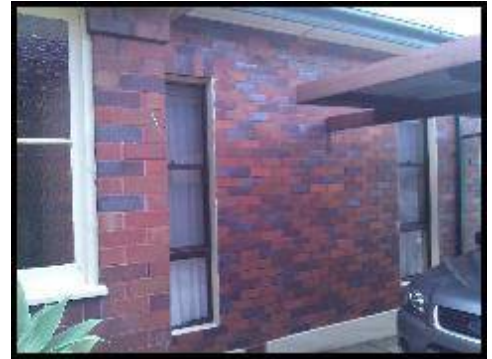
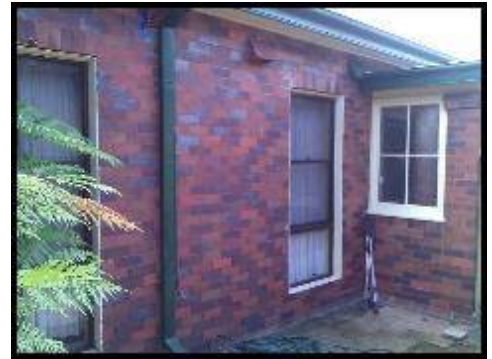
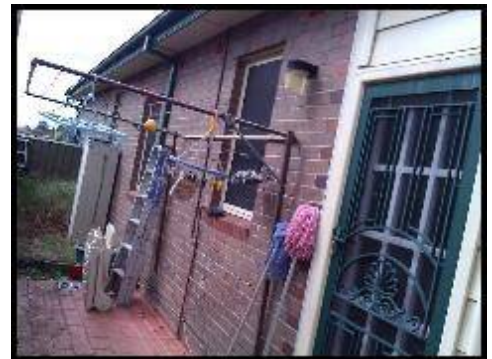
**External Walls:**

**Noted Defect:** Mortar joints between brickwork is deteriorating in various areas. No apparent structural issues were noted.

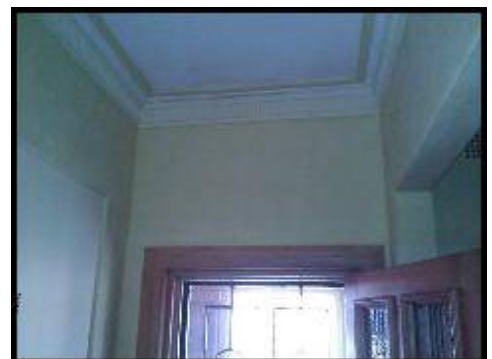
### Entry/Foyer:

**Noted Defect:** No apparent structural defects are noted.

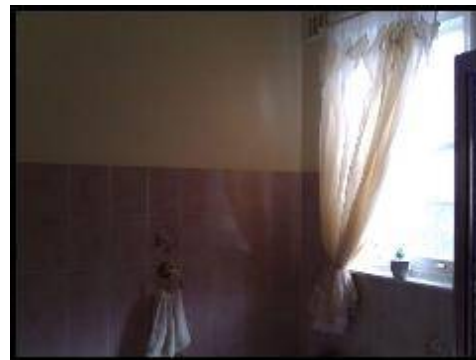
### Bathroom

**Noted Defect:** No apparent structural defects are noted.

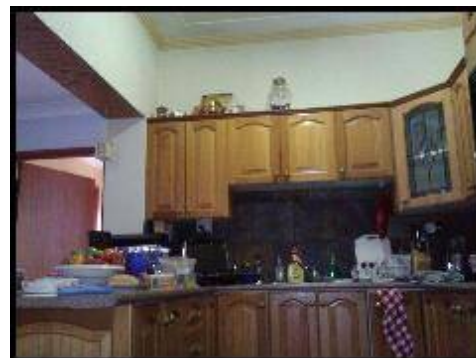
**Kitchen**

**Noted Defect:** No apparent structural defects are noted.

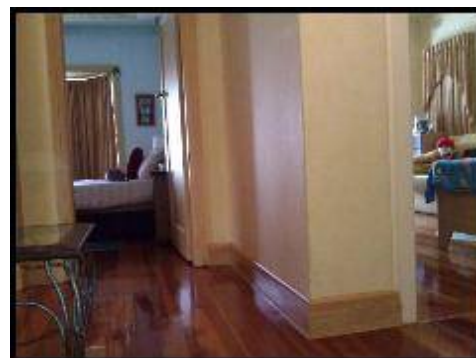
**Hallway:**

**Noted Defect:** No apparent structural defects are noted.

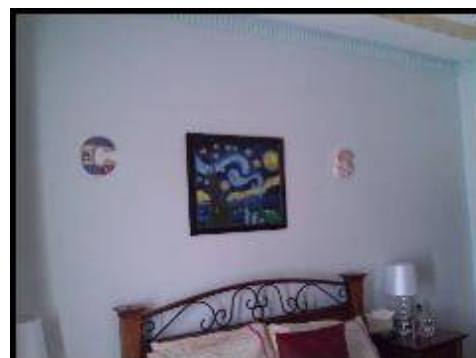
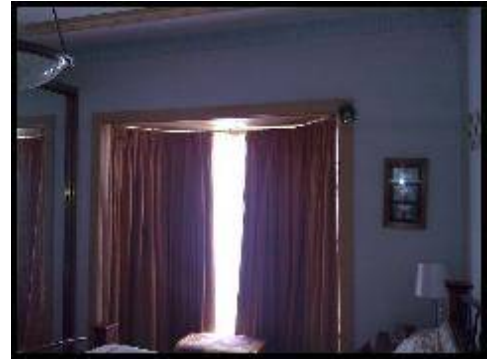
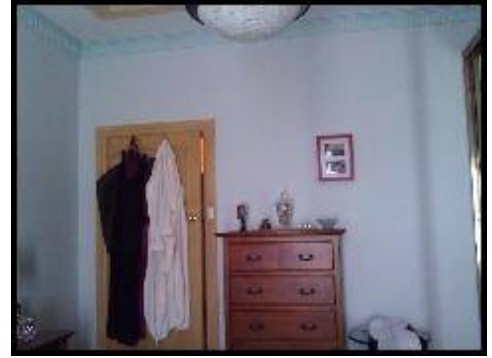
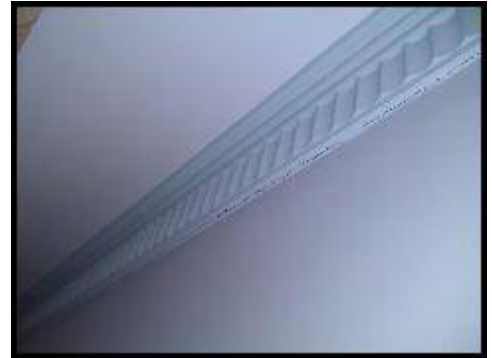
**Main Bedroom**

Some minor cracking is noted to the cornice line.

**Internal Walls Condition:** The condition of the walls is generally fair.

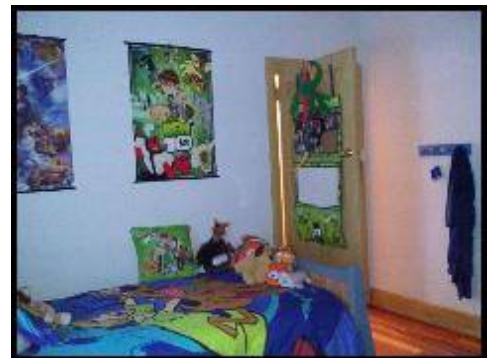
**Bedroom Two**

No apparent structural defects are noted.

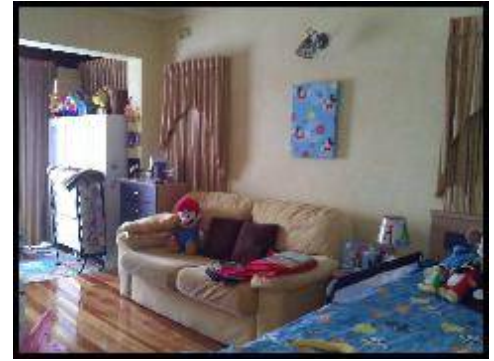
**Bedroom Three**

**Noted Defect:** No apparent structural defects are noted.

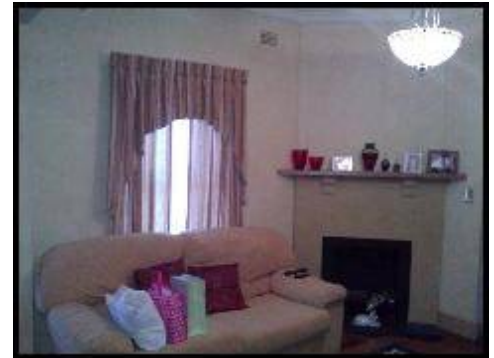
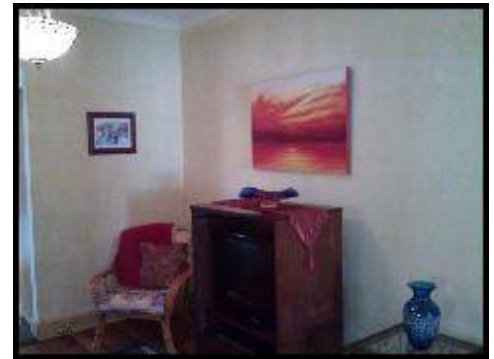
**Lounge Room:**

**Noted Defect:** No apparent structural defects are noted.

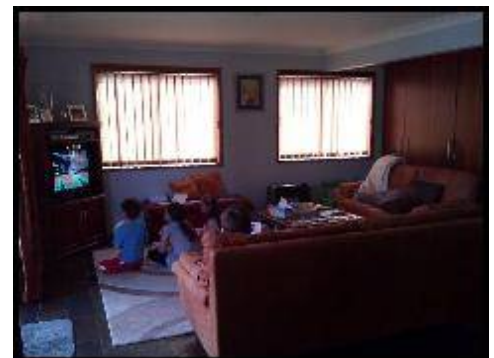
**Lounge Room Two:**

**Noted Defect:** No apparent structural defects are noted.

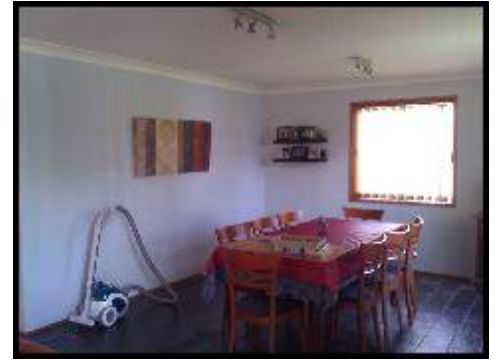
**Dining Room:**

**Noted Defect:** No apparent structural defects are noted.

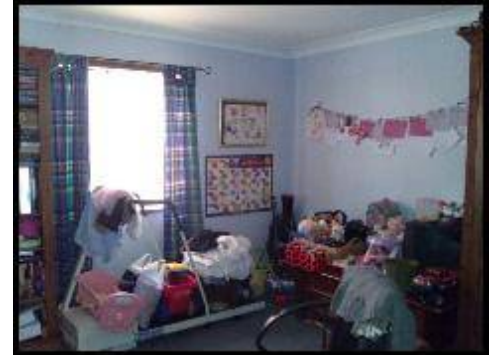
**Rumpus Room:**

**Noted Defect:** No apparent structural defects are noted.
