Visual Property Inspection Report

Complies with Australian Standard AS 4349.1-2007

Sample Street

Mr & Mrs Purchaser

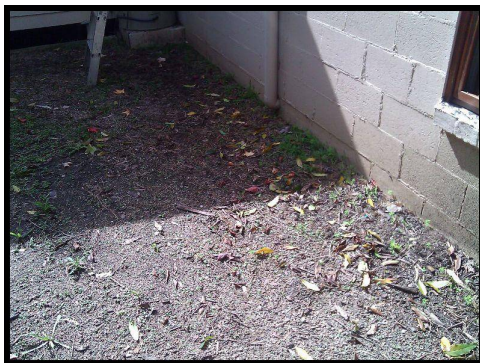
The surface water drainage at the rear of the property appears to be inadequate. Drains should be installed to divert seepage and surface runoff water away from the building to prevent possible structural damage. The drains should be connected to the existing stormwater drainage system.

Estimated cost from: \$1500.

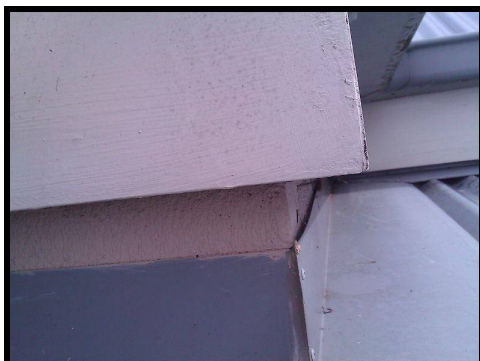
Flashing material is of preformed aluminium. Junction of the pitched roof/s and wall. Gable/s. Flashing is not or does not appear to be correctly set into the brickwork. This can allow water penetration and should be rectified. Potential water leak noted. Repair to the flashings should be considered. This area should be monitored and if leaking or damage is evident, referred to roofing experts for their assessment.

Estimated cost from: \$750.

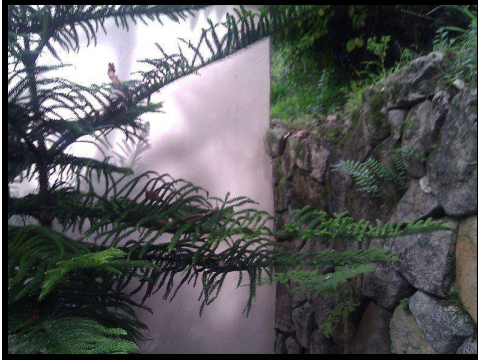
The ground levels are close or covering the damp proof course material and should be lowered to prevent dampness problems. The height of a DPC, or flashing serving as a DPC is recommended be not less than 150 mm above the adjacent ground level, 75 mm above the finished surface level of adjacent paved, concrete or landscaped areas that slope away from the wall or 50 mm above finished paved, concrete or hard landscaped areas. Base of some walls are below the external soil levels are be subject to lateral dampness or water entry. Additional waterproofing will be required or modifications will need to be made to lower moisture levels.

Estimated cost from: \$5000.

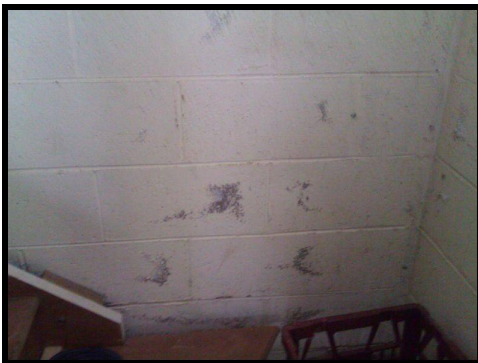
Walls to the area are moist and this may be the result of a plumbing leak, rising or lateral dampness. Recommend further invasive investigation be conducted to determine the cause of the moist area.

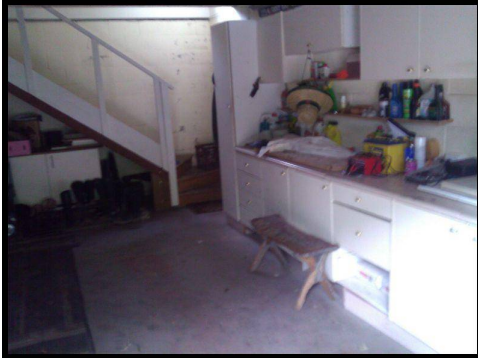
Stored items restricted inspection to the interior. These goods must be removed to enable a more complete report to be submitted. The structure is partially lined preventing inspection to some framing timbers.

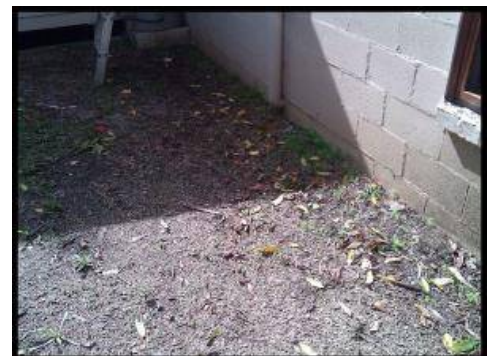
Surface Water: The surface water drainage at the rear of the property appears to be inadequate. Drains should be installed to divert seepage and surface runoff water away from the building to prevent possible structural damage. The drains should be connected to the existing stormwater drainage system.

Estimated cost from: \$1500.

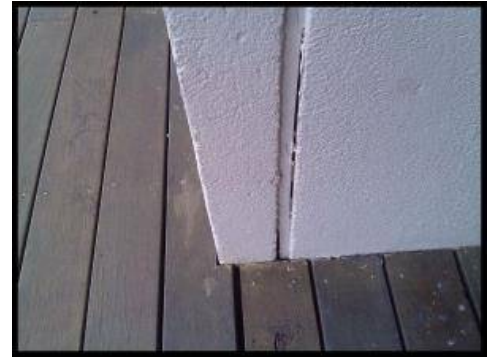
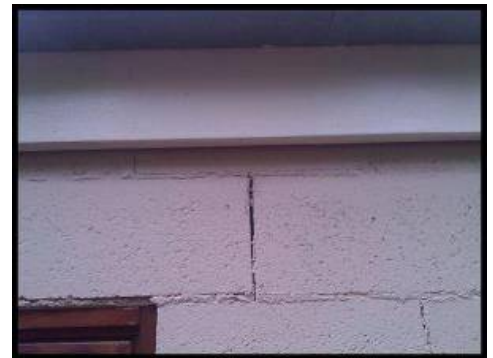
Northern elevation. Eastern elevation. Southern elevation.

Mortar joints between brickwork are deteriorating and require re pointing in areas. Shrinkage cracks are evident to rendered wall areas. This cracking generally occurs during the curing process of construction. Cracking of this type is an appearance defect and is not considered to be of a structural nature. Some repairs may be required prior to next painting to provide a suitable finish. Expansion joints to the brickwork are showing movement and require maintenance.

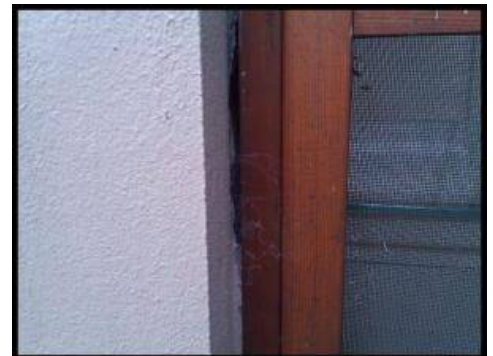
Storm moulds are not present and need to be fitted to ensure water does not penetrate wall cavity. Rectification is required. Minor maintenance and or repairs are required prior to next repainting.

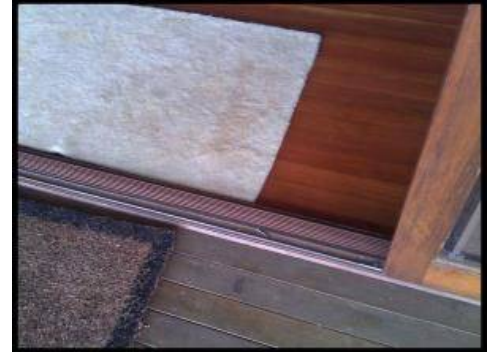
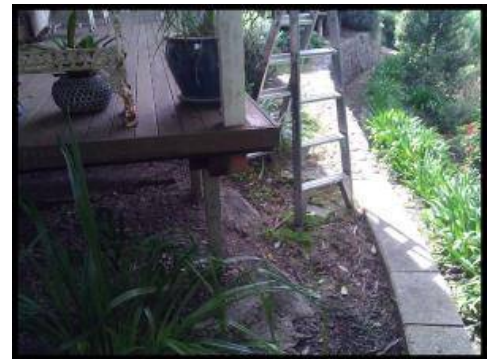
Defects Or Maintenance Items: The area has a drop greater than 1 metre from the floor and a balustrade should be installed to comply with Standards. There is no step down between external and internal floors. This situation will allow wind driven rain to penetrate from the exterior of the building. Lack of suitable stepdown may be considered a latent defect. Timber flooring is loose and requires re fixing.

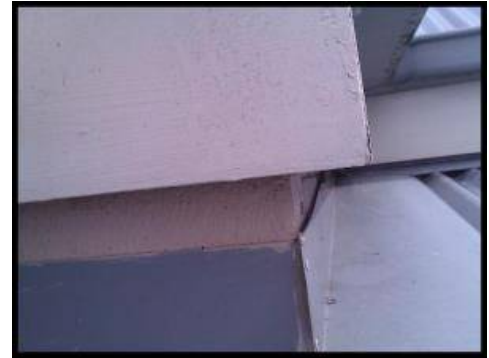
Flashing material is of preformed aluminium. Junction of the pitched roof/s and wall. Gable/s. Flashing is not or does not appear to be correctly set into the brickwork. This can allow water penetration and should be rectified. Potential water leak noted. Repair to the flashings should be considered. This area should be monitored and if leaking or damage is evident, referred to roofing experts for their assessment.

Estimated cost from: \$750.

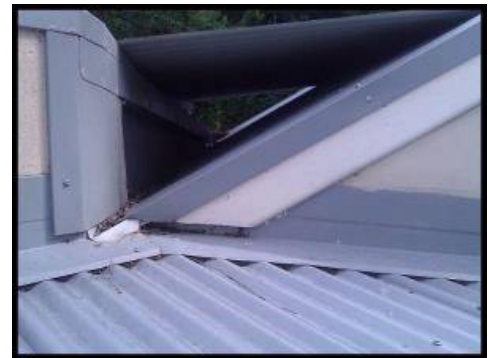
Leaves and debris are present in gutters and the guttering should be cleared. Downpipes appear to be connected to the stormwater dispersal system, however, correct connection can only be confirmed with a smoke test. Leaf guards are present to guttering and or valleys restricting inspection of these areas. Defects may be present and not detected. The design and position of the guttering is such that during wet conditions it appears that the gutter may back flow into the eave or building. Recommend the area be evaluated during wet conditions. Some modifications may be required. The roof area has a boxed gutter installed that is located above an internal section of the building. These type of gutters require regular maintenance to keep clear and prevent overflow. Any leaking, from over flow, poor joints or damage, will allow water to enter the building. Recommend this area be closely monitored for water entry.

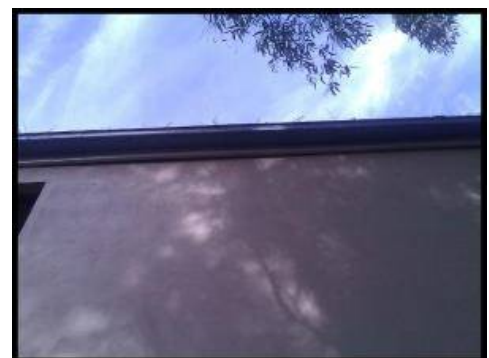
The eaves appear to be lined with fibre cement sheeting. The overall condition of the eaves lining is fair. Parts of this building does not have an eave overhang and as such may be subject to water entry if the guttering backflows during wet conditions. Recommend this area be closely monitored.

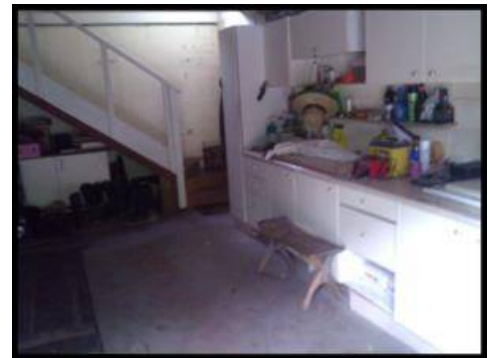
Restrictions: Stored items restricted inspection to the interior. These goods must be removed to enable a more complete report to be submitted. The structure is partially lined preventing inspection to some framing timbers.

Defects and or damage requiring rectification may not be apparent to the inspector due to this restriction. Recommend access be gained.

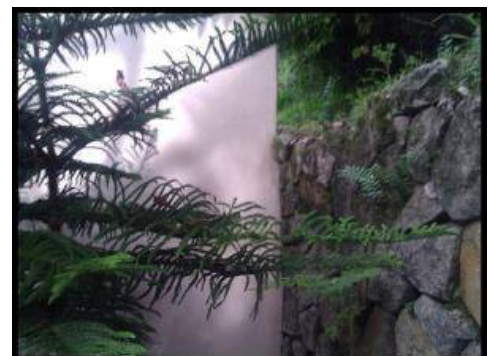
Position/Location: Eastern elevation. Southern elevation. Western elevation.

Wall Condition: The ground levels are close or covering the damp proof course material and should be lowered to prevent dampness problems. The height of a DPC, or flashing serving as a DPC is recommended be not less than 150 mm above the adjacent ground level, 75 mm above the finished surface level of adjacent paved, concrete or landscaped areas that slope away from the wall or 50 mm above finished paved, concrete or hard landscaped areas. Base of some walls are below the external soil levels are be subject to lateral dampness or water entry. Additional waterproofing will be required or modifications will need to be made to lower moisture levels.

Estimated cost from: \$5000.

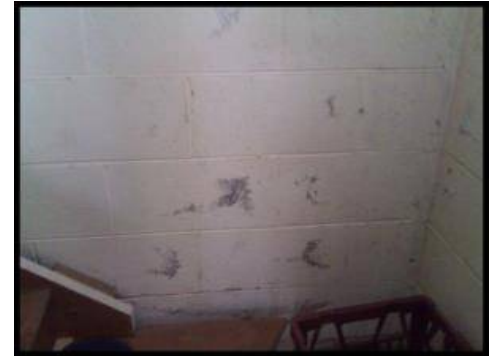
- Lintels - Type & Condition:** Lintel type/s noted: Mild steel. The condition of the lintels is generally fair.
- Front Doors - Type & Condition:** The main garage door is a roller shutter style door and is in fair condition.
- Floor - Type & Condition:** The concrete floor is generally in fair condition.
- Ceiling Condition:** There is no ceiling lining present.
- Internal Walls Condition:** Walls to the area are moist and this may be the result of a plumbing leak, rising or lateral dampness. Recommend further invasive investigation be conducted to determine the cause of the moist area.

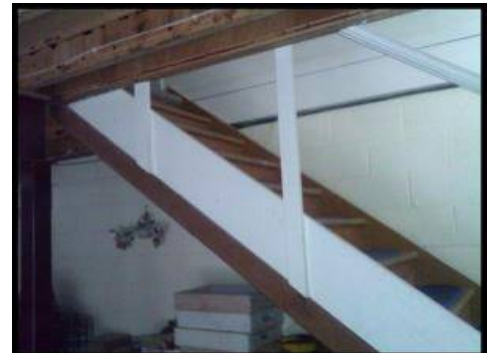
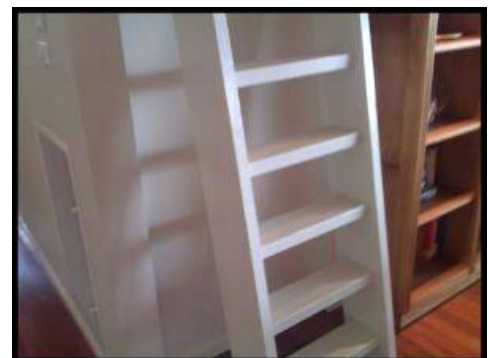
Stairs Condition: The stairs are constructed primarily from timber. The handrails and balustrades do not comply with Standards for height and or spacing. Recommend they be updated. Rise and going (height & depth) of treads is hazardous and does not comply with current Standards. Recommend these areas be modified.

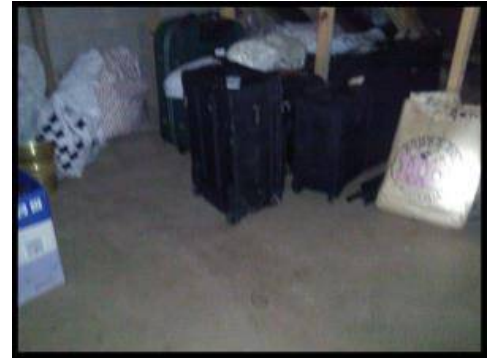
Sarking membrane covered tile battens restricting inspection. Lining material has been placed over some ceiling timbers for storage purposes which prevented inspection of those covered timbers. Stored goods restricted inspection within this area. Inspection was restricted above the following locations and or areas: Bathroom. Garage.

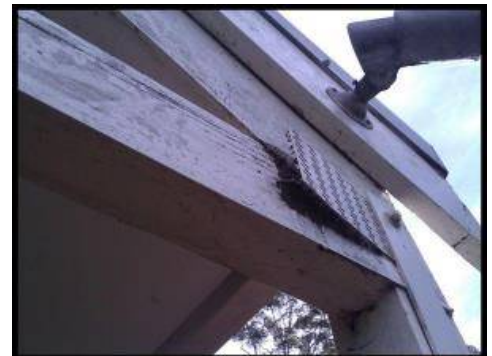
Roof trusses have been damaged and do not appear to be structurally adequate. A roof truss is a structural eliminate of the roof frame and if altered or damaged can has adversely affecting the roof structurally. Repair or replacement of the roof truss will be required. A structural engineer should be engaged to provide an opinion as to the structural adequacy of the roof support system and repairs.

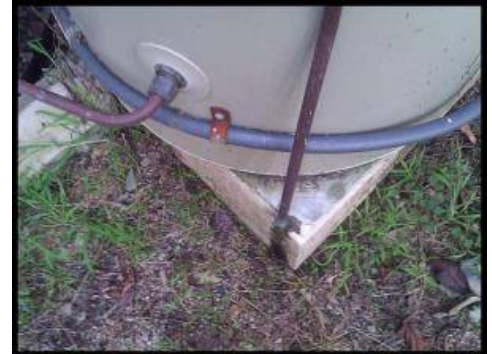
Type/Condition: Mains electric hot water system: Mains pressure: Located externally: The hot water system appears to be in working condition. No specific tests other than running the hot water tap were carried out. No determination has been made as to the suitability or adequacy of the hot water system in relation to capacity or otherwise. Hot water overflow pipe should be diverted away from the external walls. Damp soil around the building may cause swelling and lead to heaving of structure and cracking to walls. Moisture also encourages termites into the area. We strongly recommend the overflow relief valve be connected to a drainage point.
