PROPERTY INSPECTIONS BY BUILDING CONSULTANTS

Visual Property Inspection Report

Complies with Australian Standard AS 4349.1-2007 & 4349.3

VISUAL BUILDING INSPECTION REPORT

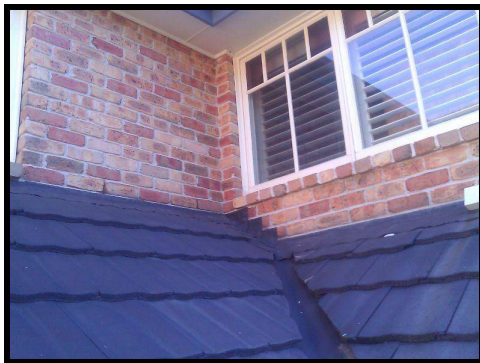
Flashing material is of lead. Flashing is split, in poor condition and will require rectification to the following areas; Junction of the pitched roof/s and wall. Recommend the installation of a soaker or apron flashing to roof junction/s. Failure to install these flashings may cause water entry and damage to property. These flashings should be installed to comply with Standards.

Estimated cost from: \$750.

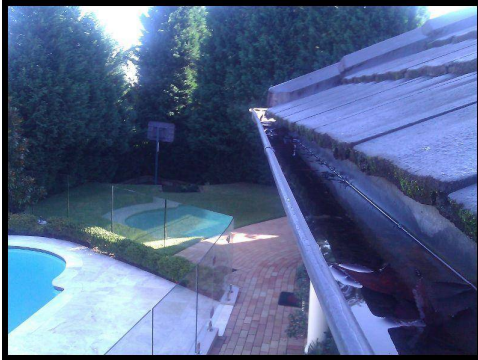
Downpipes are damaged or rusting and should be repaired or replaced as necessary. Water is ponding in the gutters and they require realigning. Guttering joints are leaking and repairs/maintenance required. Downpipes appear to be connected to the stormwater dispersal system, however, correct connection can only be confirmed with a smoke test.

Estimated cost from: \$1000.

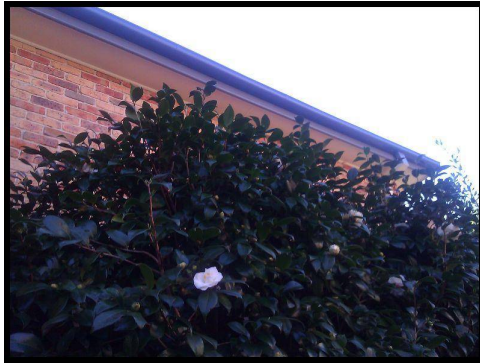
Inspection to sections of the exterior was restricted due to the growth of foliage. Foliage must be removed to enable a more complete report to be submitted. Inspection to sections of the exterior was restricted due to the stored goods. These goods must be removed to enable a more complete report to be submitted. Western of the structure. Inspection to the following fencing timbers was restricted in part by foliage - Right hand side fence.

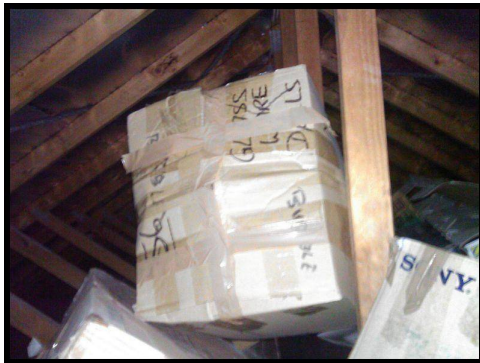
Sarking paper and insulation is present in the roof cavity. This restricted inspection to some roofing timbers. Removal of insulation is not within the scope of a standard visual building inspection report. Lining material has been placed over some ceiling timbers for storage purposes which prevented inspection of those covered timbers. Stored goods restricted inspection within this area. Inspection was restricted above the following locations and or areas: Garage.

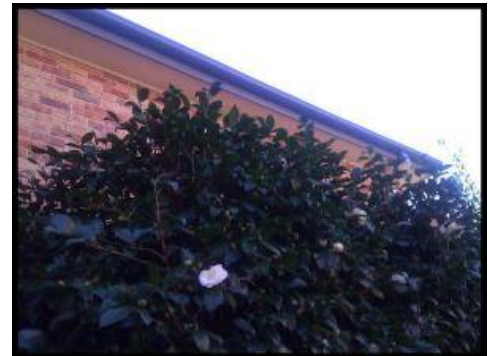
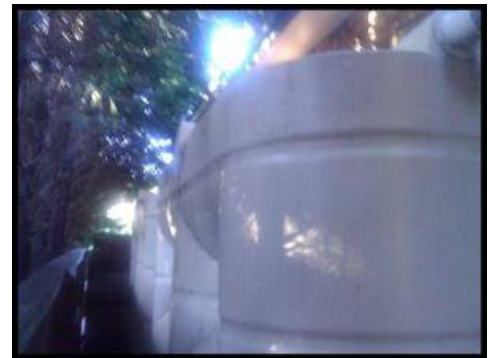
| Restrictions: | Inspection to sections of the exterior was restricted due to the growth of foliage. Foliage must be removed to enable a more complete report to be submitted. Inspection to sections of the exterior was restricted due to the stored goods. These goods must be removed to enable a more complete report to be submitted. Western of the structure. Inspection to the following fencing timbers was restricted in part by foliage - Right hand side fence. |

Defects and or damage requiring rectification may not be apparent to the inspector due to restriction. If restrictions are noted we STRONGLY recommend access be gained to enable a full inspection of the area.

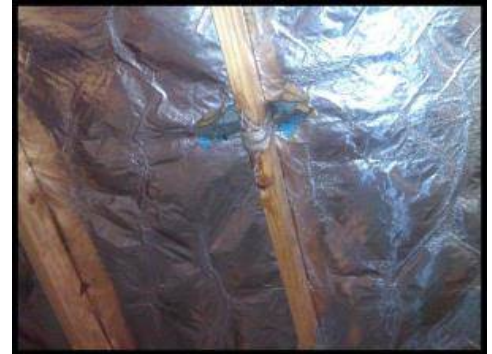
A small number of cracked roof tiles were noted and should be replaced. Mortar beds to the hip and ridge capping are cracked and require maintenance or re bedding and pointing in areas. Roof and/or flashings are allowing water to penetrate the interior of the building. Concealed internal roofing members may be damaged and require repair or replacement. This should be investigated further by a licensed contractor and rectified.

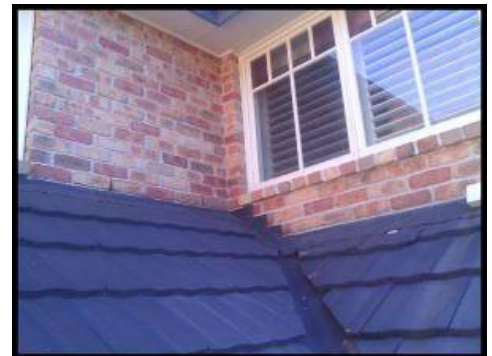
Flashing material is of lead. Flashing is split, in poor condition and will require rectification to the following areas; Junction of the pitched roof/s and wall. Recommend the installation of a soaker or apron flashing to roof junction/s. Failure to install these flashings may cause water entry and damage to property. These flashings should be installed to comply with Standards.

Estimated cost from: \$750.

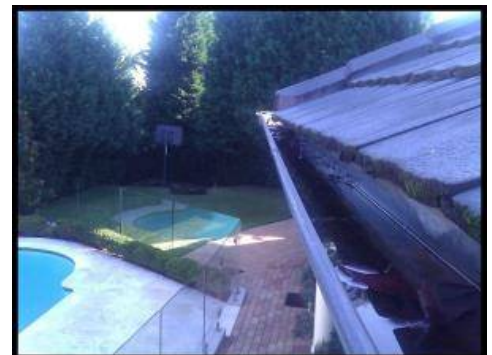
Downpipes are damaged or rusting and should be repaired or replaced as necessary. Water is ponding in the gutters and they require realigning. Guttering joints are leaking and repairs/maintenance required. Downpipes appear to be connected to the stormwater dispersal system, however, correct connection can only be confirmed with a smoke test.

Estimated cost from: \$1000.

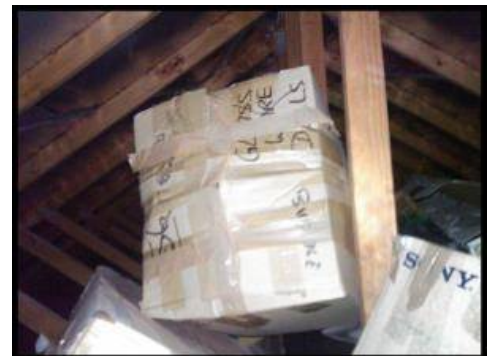
- Restrictions:** Sarking paper and insulation is present in the roof cavity. This restricted inspection to some roofing timbers. Removal of insulation is not within the scope of a standard visual building inspection report. Lining material has been placed over some ceiling timbers for storage purposes which prevented inspection of those covered timbers. Stored goods restricted inspection within this area. Inspection was restricted above the following locations and or areas: Garage.

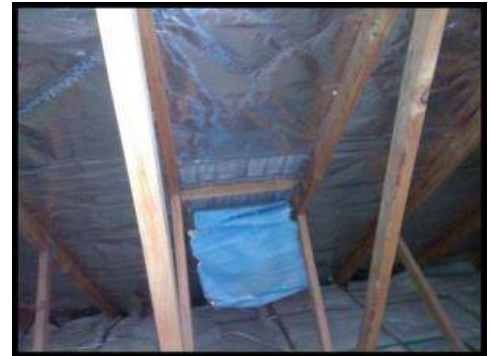
Sarking has been provided to the roof area. Sarking is present but is torn or has holes in some areas. This may affect the waterproofing ability of the sarking and damaged areas should be considered for repair.

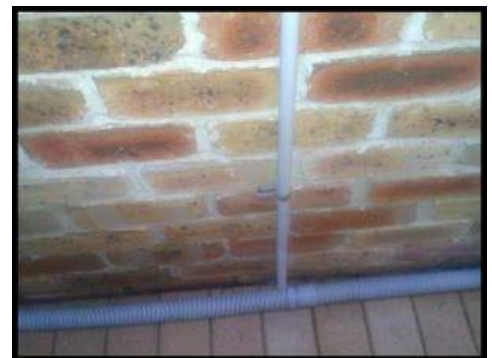
Gas is connected to the premises, however, has not been evaluated and should be inspected by a qualified gas fitter. Water tank/s present, however, has not been evaluated and should be inspected by a qualified plumber. Smoke detectors are fitted, however, the positioning, operation or adequacy was not tested and is not commented on. An earth leakage circuit breaker (safety switch) appears to be installed to the electrical switch board. Positioning, operation or adequacy was not tested. The evaluation of air-conditioning is not part of a standard pre purchaser building inspection report and is the subject of a special purpose report. We recommend this be carried out by a specialist in air-conditioning installation, maintenance and control. Air-conditioning condensation discharge pipe should be diverted away from the external walls. Damp soil around the building may cause swelling and lead to

heaving of structure and cracking to walls. Moisture also encourages termites into the area. We strongly recommend this pipe be connected to a drainage point. An alarm system is present, however, the operation or adequacy was not tested.

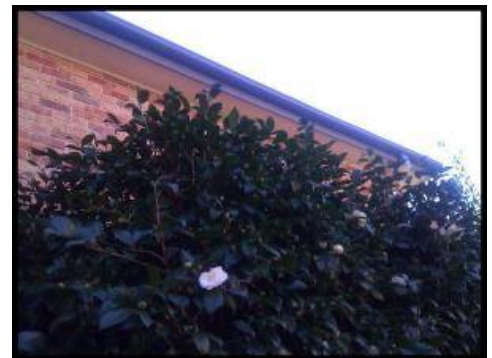
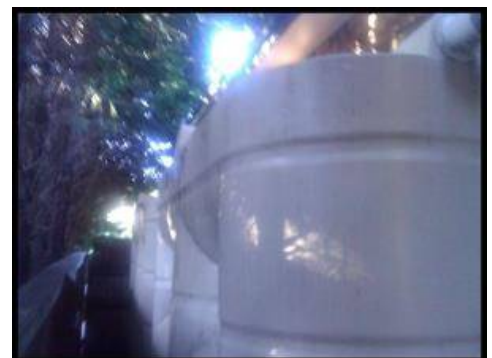
Inspection to sections of the exterior was restricted due to the growth of foliage. Foliage must be removed to enable a more complete report to be submitted. Inspection to sections of the exterior was restricted due to the stored goods. These goods must be removed to enable a more complete report to be submitted. Western of the structure. Inspection to the following fencing timbers was restricted in part by foliage - Right hand side fence.

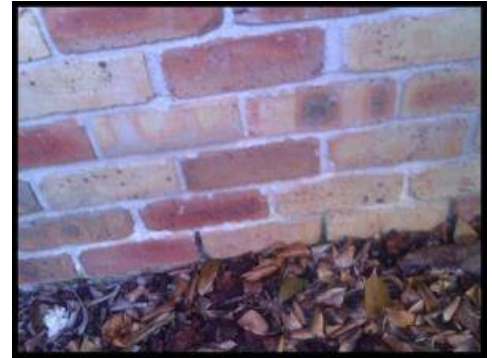
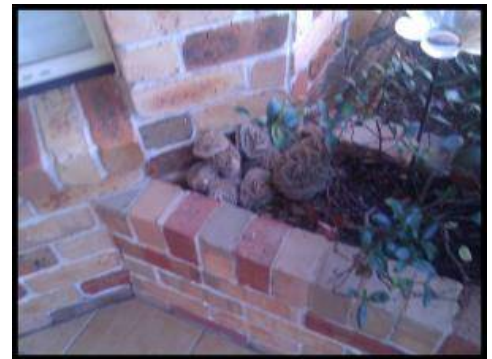
The air-conditioning condenser discharges adjacent to the external walls. We recommend modification so that water is discharged over a drain. The fence or fence posts are in direct contact with the building structure. This situation can allow termites to enter the structure and we recommend that suitable modifications be made so that fencing timbers are not in direct contact with the structure. The external vents/weep holes are either covered completely or partly concealed. This can allow concealed termite entry and we recommend that all vents/weep holes be exposed and kept clear of soil, foliage, debris, stored items or other obstructions. Some gutters and/or downpipes appear to discharge rainwater directly adjacent to the foundations of the structure. These should be connected to a stormwater dispersal system. The level of some external paths, paved areas or soil is either higher than, or at a similar level, as that of the internal floors. This situation could allow concealed termite entry. We strongly recommend the lowering of these to below the internal floor level to reduce the risk of concealed termite entry. Garden beds have been built up against the external walls. These should be removed as they can allow concealed termite entry.

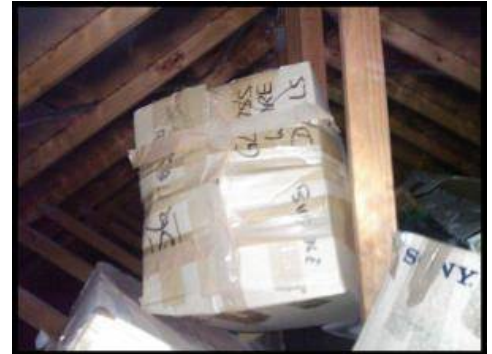
Sarking paper and insulation is present in the roof cavity. This restricted inspection to some roofing timbers. Removal of insulation is not within the scope of a standard visual building inspection report. Lining material has been placed over some ceiling timbers for storage purposes which prevented inspection of those covered timbers. Stored goods restricted inspection within this area. Inspection was restricted above the following locations and or areas: Garage.
