# Inspect it

## Visual Property Inspection Report

Complies with Australian Standard AS 4349.1-2007

**Sample Street**

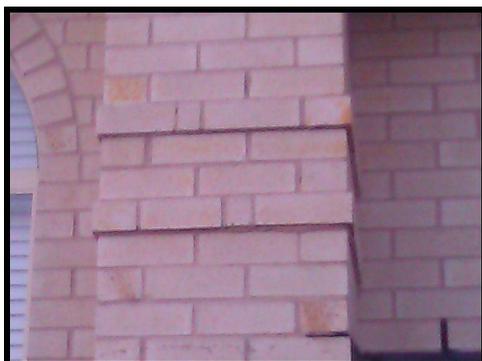
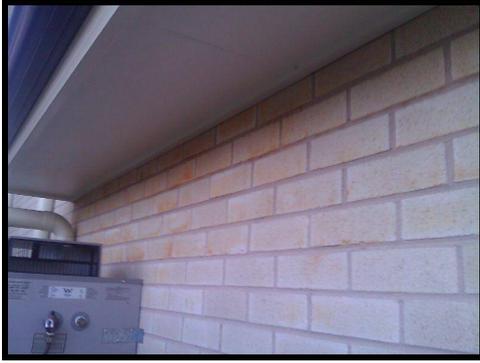
Mortar joints between brickwork have not been ironed correctly and are inconsistent with the rest of the building (corbel course above front entry, behind downpipe of garage)

Brickwork is discoloured in areas or has been poorly blended and recommend an expert from the brick supplier be requested to provide a further evaluation.

Northern elevation. Eastern elevation. Western elevation.

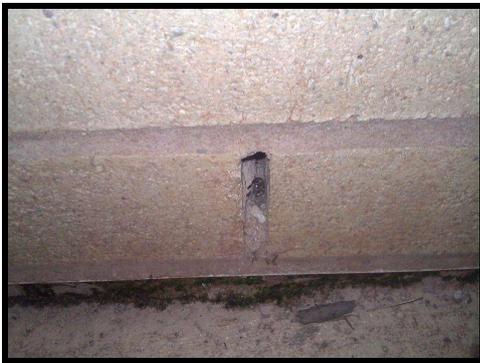
Weep holes to the base of the brick walls are blocked or partly blocked by mortar and should be cleared to help prevent moisture and pest problems.

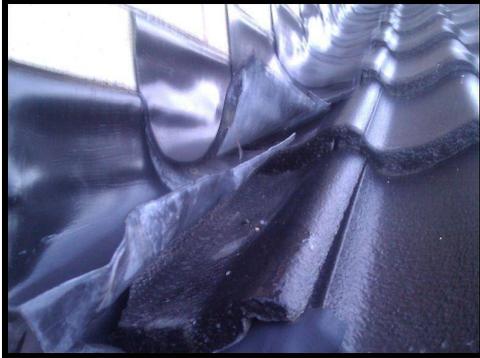
Flashing material is of lead. Recommend the installation of a soaker or apron flashing to step flashings to prevent water entry and to comply with Standards. Rectification will be required.

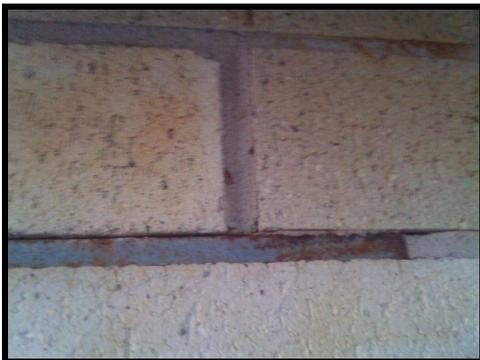
Lintel type/s noted: Mild steel. Rust is evident to some steel lintels. Rusted areas should be treated to prevent further deterioration.

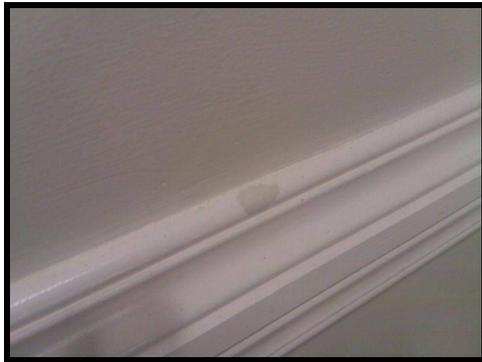
Painting is not complete, appears transparent and requires rectification to provide a suitable finish.

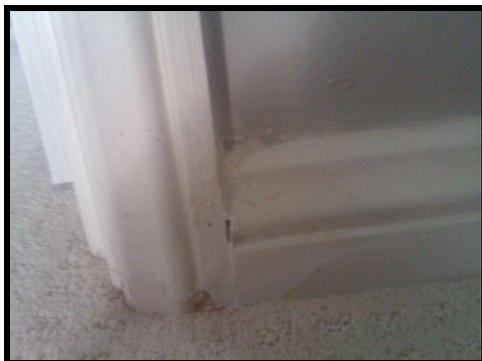
Settlement cracks are evident to wall areas. Rectification will be required.

Flooring is uneven and squeaking flooring was noted. These areas should be leveled and secured to prevent movement.

The condition of the woodwork is generally poor. Rectification will be required.

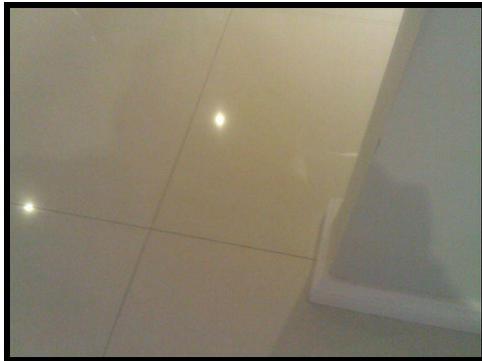
Cracking is present to cornices and these areas will require maintenance and or repair.

Walls have not been installed square/parallel with the tiling. Rectification will be required.

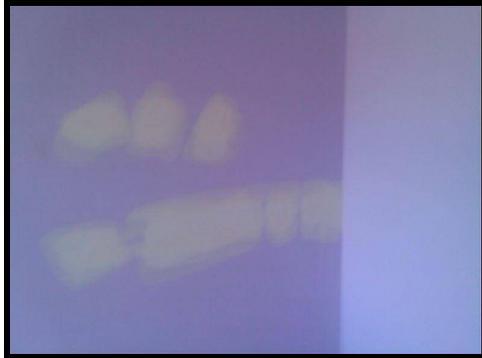
Poor joint setting was noted to some walls. Painting is in poor condition and recommend repainting to provide an acceptable finish.

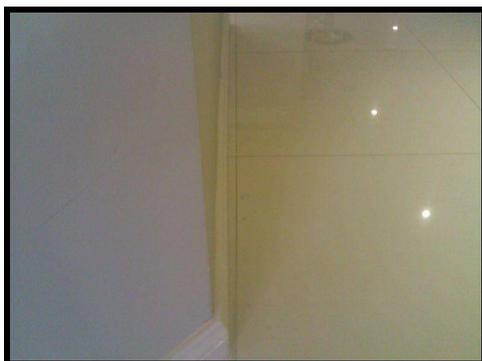
Painting is in poor condition and recommend repainting. Walls have not been installed square/parallel with the tiling. Rectification will be required.

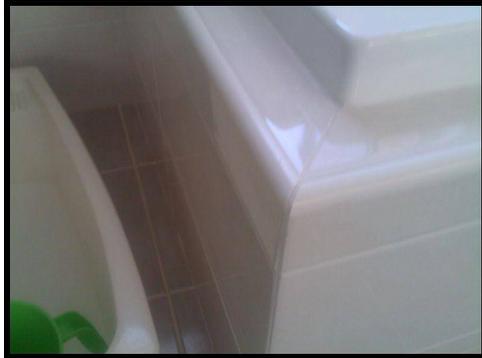
The quality of the tiling is poor to the bath hob area. Rectification will be required.

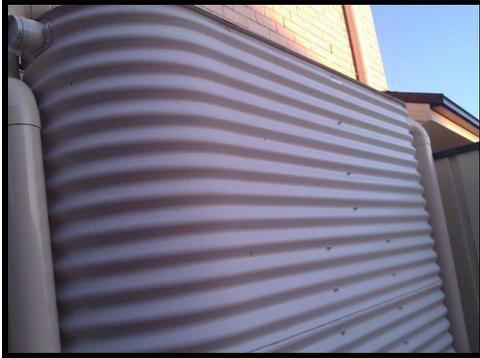
Inspection to sections of the exterior was restricted due to the stored goods/water tank. These goods must be removed to enable a more complete report to be submitted. Inspection was limited in the following locations and or areas: Eastern elevation.

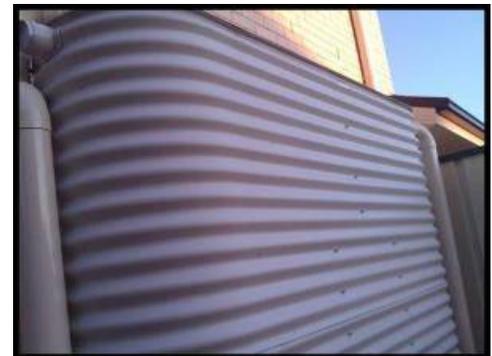
<b>Restrictions:</b>	Inspection to sections of the exterior was restricted due to the stored goods/water tank. These goods must be removed to enable a more complete report to be submitted. Inspection was limited in the following locations and or areas: Eastern elevation.
----------------------	--

Defects and or damage requiring rectification may not be apparent to the inspector due to this restriction. Recommend access be gained.

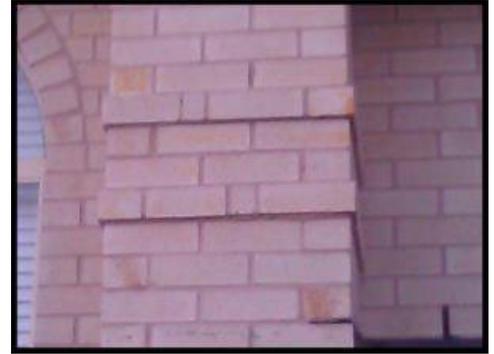
The ground levels are close or covering the damp proof course material and should be lowered to prevent dampness problems. The height of a DPC, or flashing serving as a DPC is recommended be not less than 150 mm above the adjacent ground level, 75 mm above the finished surface level of adjacent paved, concrete or landscaped areas that slope away from the wall or 50 mm above finished paved, concrete or hard landscaped areas.

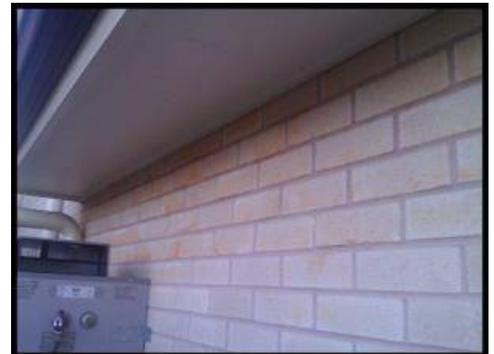
Mortar joints between brickwork have not been ironed correctly and are inconsistent with the rest of the building (corbel course above front entry, behind downpipe of garage)

Brickwork is discoloured in areas or has been poorly blended and recommend an expert from the brick supplier be requested to provide a further evaluation.

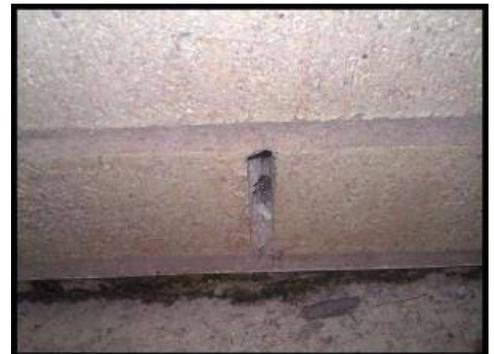
Weep holes to the base of the brick walls are blocked or partly blocked by mortar and should be cleared to help prevent moisture and pest problems.

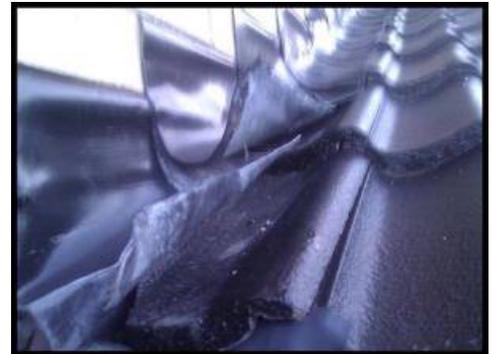
**Roof Flashing - Type And Condition:** Flashing material is of lead. Recommend the installation of a soaker or apron flashing to step flashings to prevent water entry and to comply with Standards. Rectification will be required.

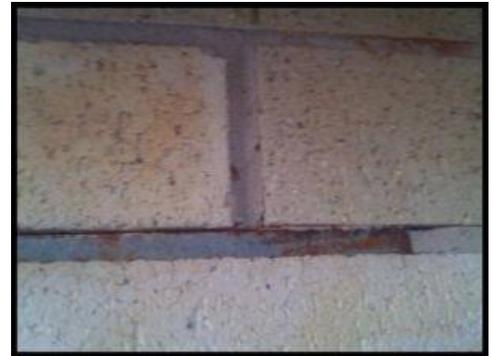
**Lintels - Type & Condition:** Lintel type/s noted: Mild steel. Rust is evident to some steel lintels. Rusted areas should be treated to prevent further deterioration.

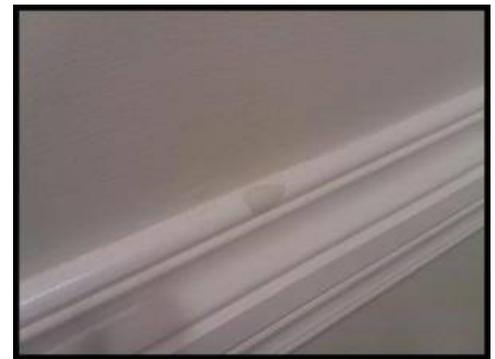
- Ceiling Condition:** The condition of the ceiling area is generally acceptable.  
**Internal Walls Condition:** Painting is not complete, appears transparent and requires rectification to provide a suitable finish.  
**Floors Condition:** The condition of the floor area is generally acceptable.  
**Woodwork:** Painting is not complete, appears transparent and requires rectification to provide a suitable finish.

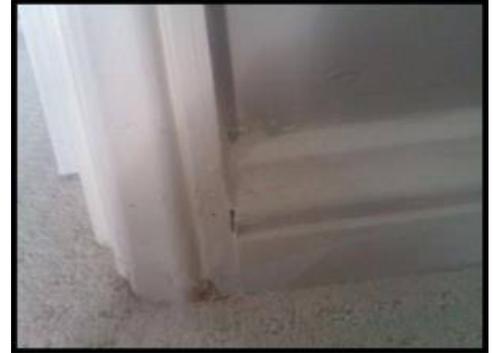
Inspection to the upperside of flooring was restricted by carpets.  
**Ceiling Condition:** The condition of the ceiling area is generally acceptable.  
**Internal Walls Condition:** Settlement cracks are evident to wall areas. Rectification will be required.

**Floors Condition:** Flooring is uneven and squeaking flooring was noted. These areas should be leveled and secured to prevent movement.

**Woodwork:** The condition of the woodwork is generally poor. Rectification will be required.

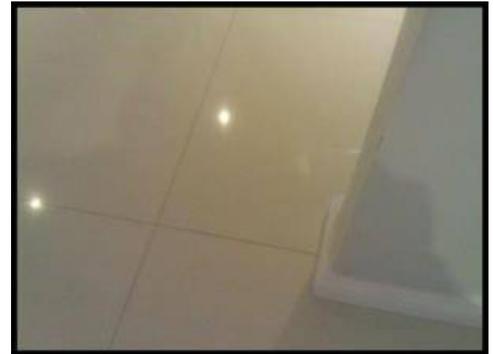
**Internal Walls Condition:** Walls have not been installed square/parallel with the tiling. Rectification will be required.

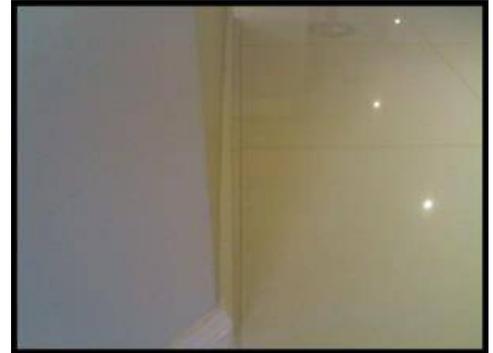
<b>Room Location:</b>	Ground floor.
<b>Ceiling Condition:</b>	The condition of the ceiling area is generally acceptable.
<b>Internal Walls Condition:</b>	Painting is in poor condition and recommend repainting. Walls have not been installed square/parallel with the tiling. Rectification will be required.

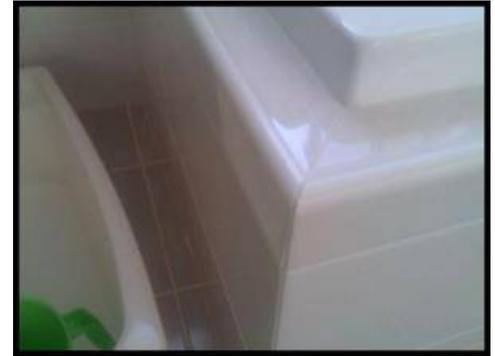
**Tiles:** The quality of the tiling is poor to the bath hob area. Rectification will be required.

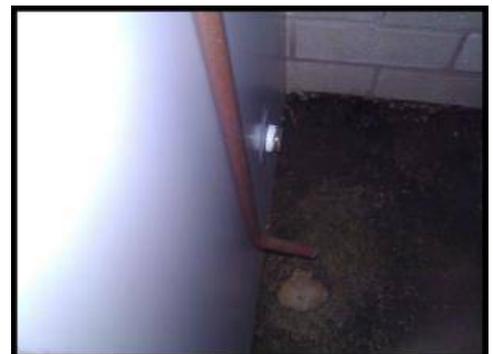
Gas hot water system: Mains pressure:  
Located externally: The hot water system appears to be in working condition. No specific tests other than running the hot water tap were carried out. No determination has been made as to the suitability or adequacy of the hot water system in relation to capacity or otherwise. Hot water overflow pipe should be diverted away from the external walls. Damp soil around the building may cause swelling and lead to heaving of structure

and cracking to walls. Moisture also encourages termites into the area. We strongly recommend the overflow relief valve be connected to a drainage point.
