## Visual Dilapidation Inspection Report

**Sample Street**

## VISUAL INSPECTION REPORT

**Report Type:** Visual Dilapidation Building Inspection.

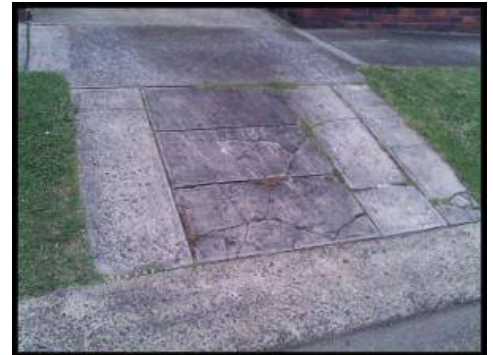
### Driveway:

Driveway has some minor cracking, also some minor subsidence at the street entrance.

Located; Driveway, Width; 1-2mm, Length; Various.

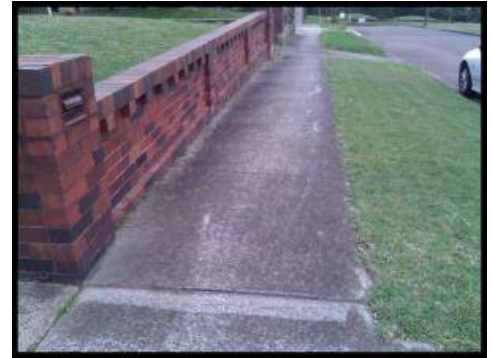
### Foot Path:

No apparent structural defects are noted to the footpath.

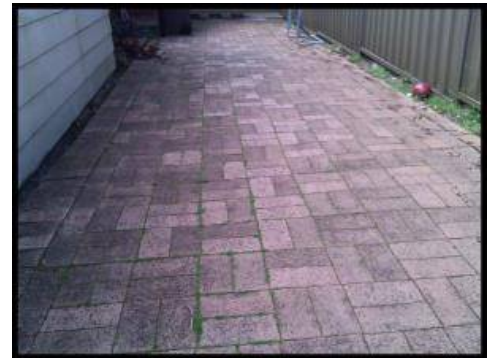
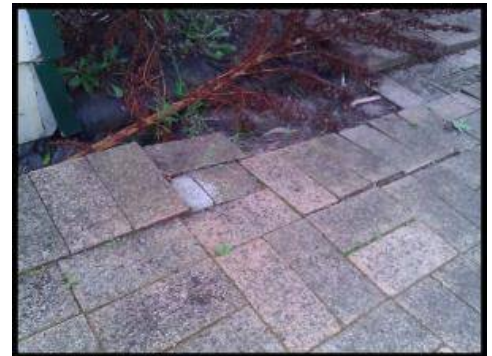
**Paths:**

Paved areas have subsided in various areas.

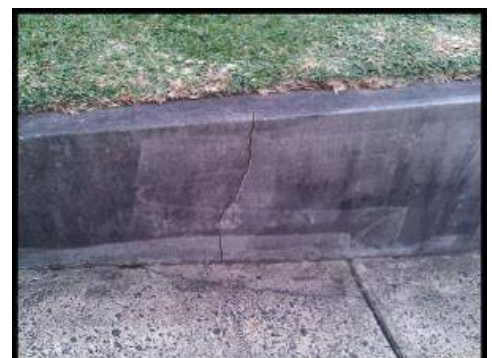
**Retaining Walls:**

Retaining wall has some minor cracking at the driveway area.

Located; Driveway Retaining Wall, Width; 2mm, Length; 500mm.

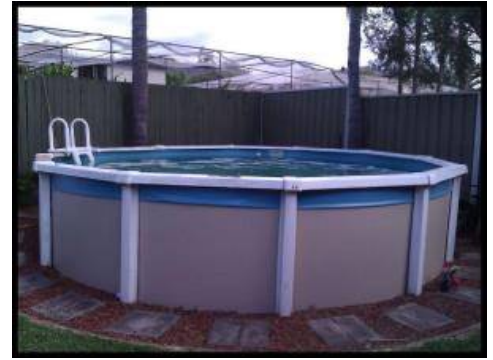
**Swimming Pool:**

**Noted Defect:** No apparent structural defects are noted.

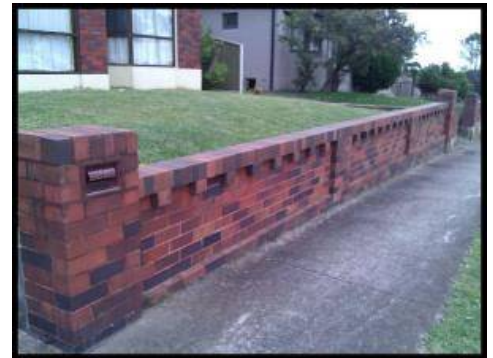
**Fencing:**

**Noted Defect:** No apparent structural defects are noted.

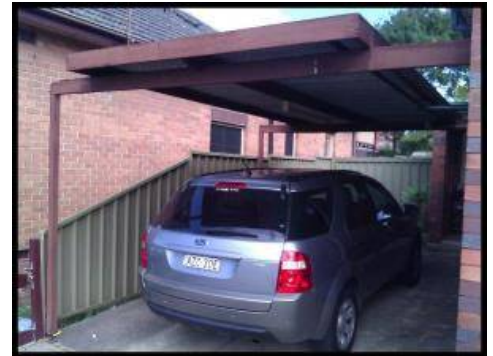
**Carport:**

**Noted Defect:** No apparent structural defects are noted.

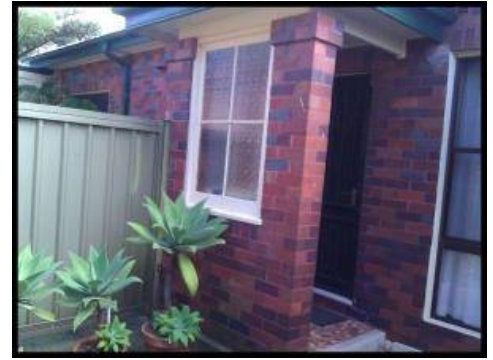
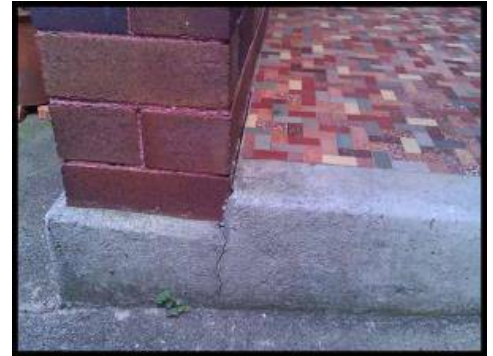
**Verandah:**

Minor cracking is noted to the concrete floor.

Located; Verandah, Width; 1-2mm, Length; 200mm.

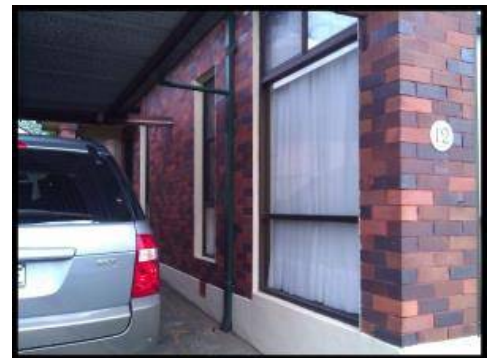
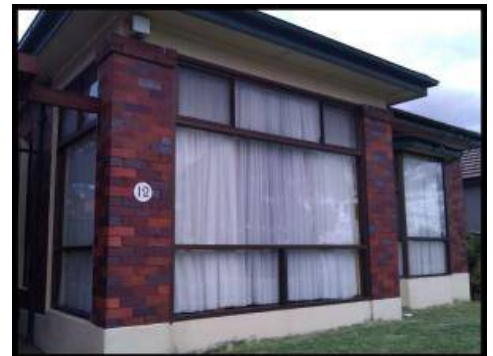
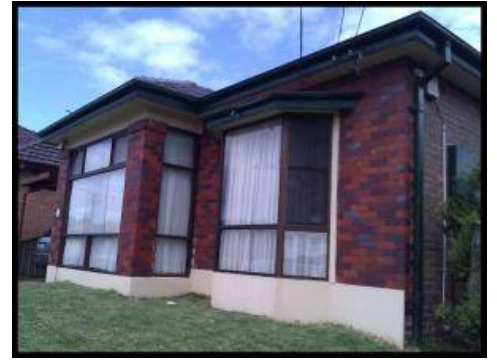
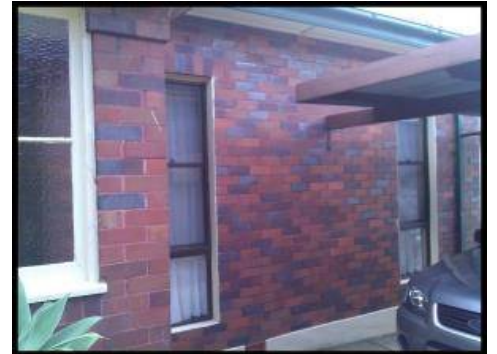
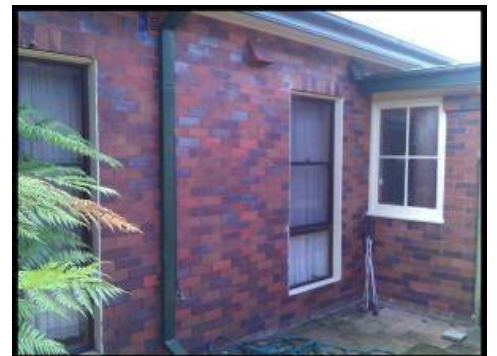
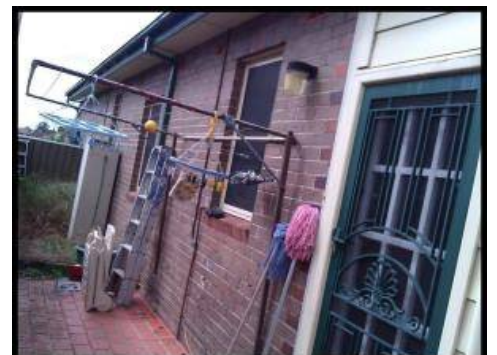
**External Walls:**

Mortar joints between brickwork is deteriorating in various areas. No apparent structural issues were noted.

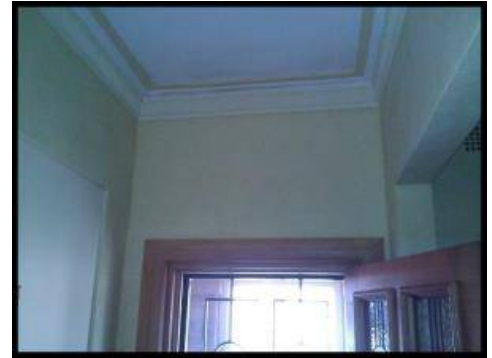
**Entry/Foyer:**

No apparent structural defects are noted.

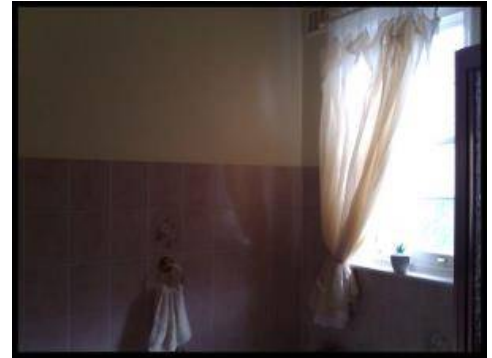
**Bathroom**

No apparent structural defects are noted.

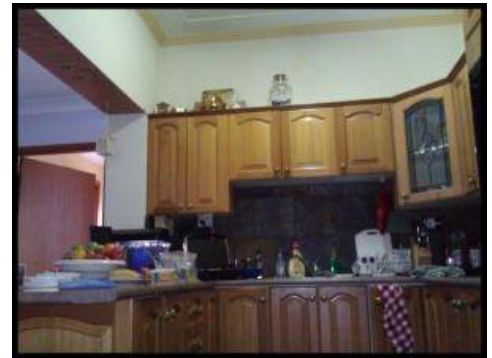
**Kitchen**

No apparent structural defects are noted.

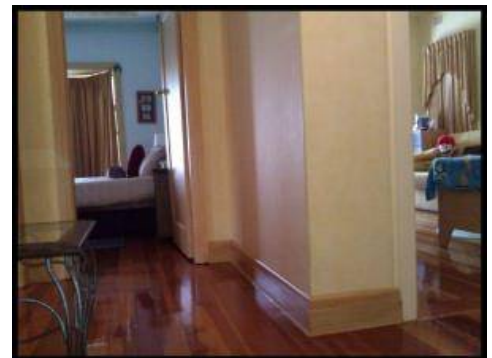
**Hallway:**

No apparent structural defects are noted.

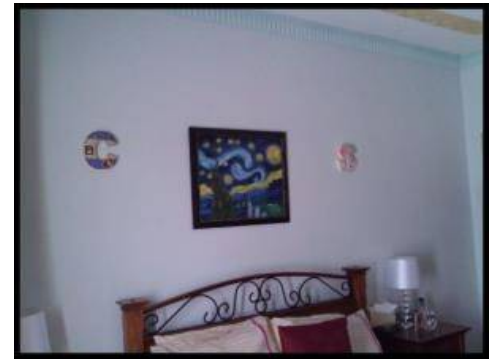
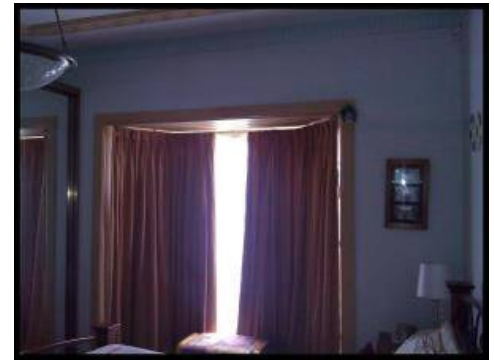
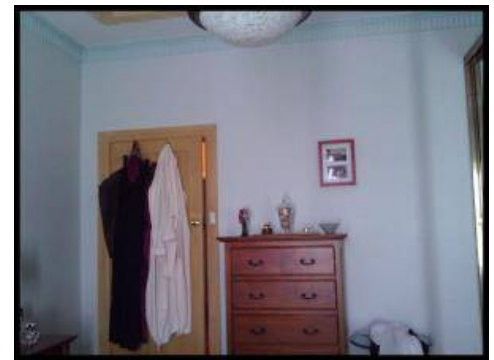
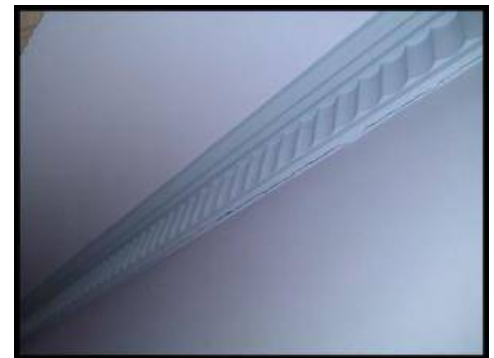
## Main Bedroom

Some minor cracking is noted to the cornice line.

**Internal Walls Condition:** The condition of the walls is generally fair.

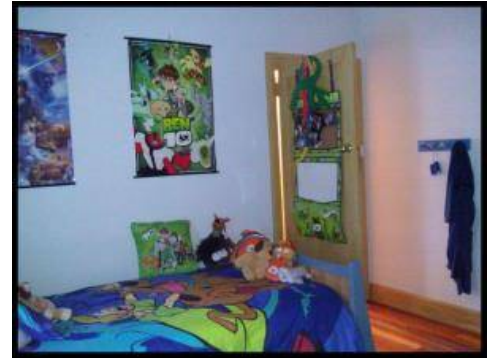
## Bedroom Two

No apparent structural defects are noted.

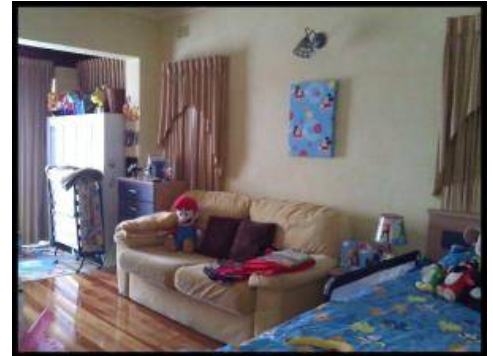
**Bedroom Three**

No apparent structural defects are noted.

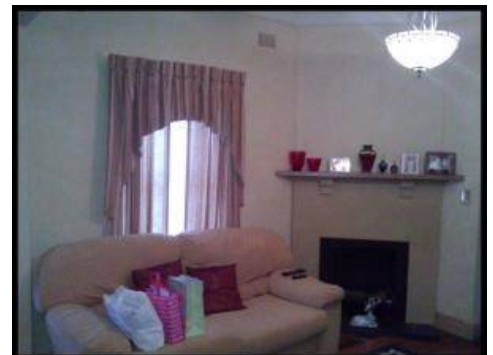
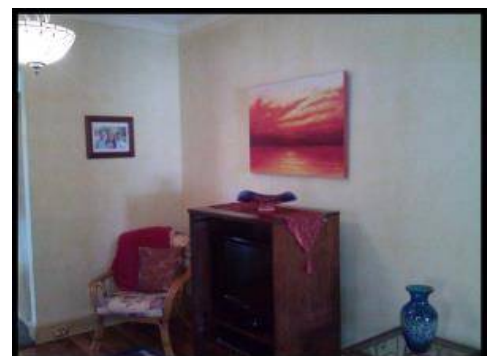
**Lounge Room:**

No apparent structural defects are noted.

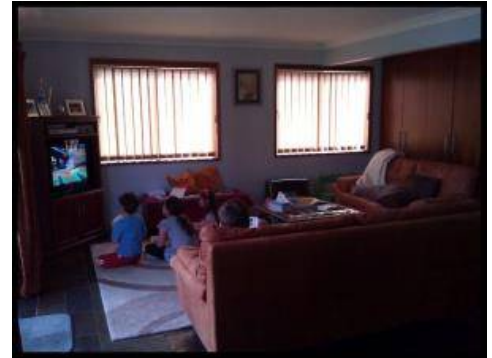
**Lounge Room Two:**

**Noted Defect:** No apparent structural defects are noted.

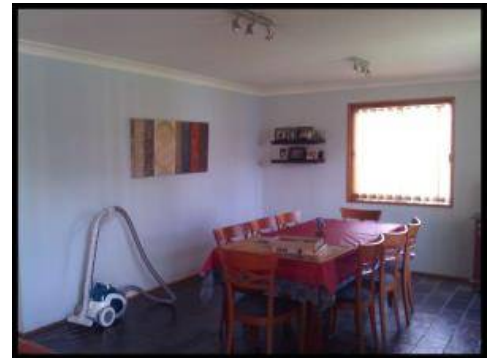
**Dining Room:**

**Noted Defect:** No apparent structural defects are noted.

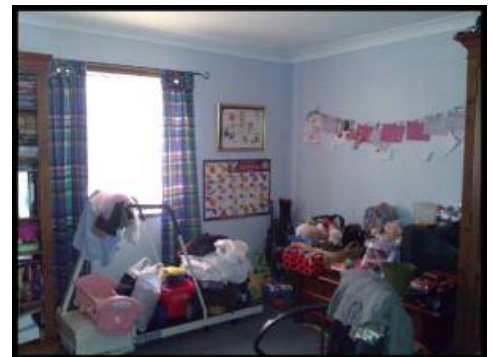
**Rumpus Room:**

**Noted Defect:** No apparent structural defects are noted.
