Visual Timber Pest Inspection Report

Sample Street

VISUAL TIMBER PEST INSPECTION REPORT

Commissioned By: Solicitor/Company.
Your Client: Mr & Mrs Purchaser.
Property Address: Sample Street.
Date Of Inspection: 17/05/2012.
Note: *If this report is associated with a contract for sale then you should not be relied upon the findings if the contract becomes binding more than 30 days after the date of initial inspection. A re-inspection after this time is essential.*
Inspector: Craig Richards
Accreditation number: 5274

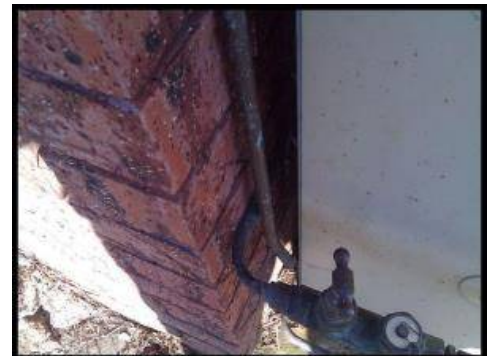
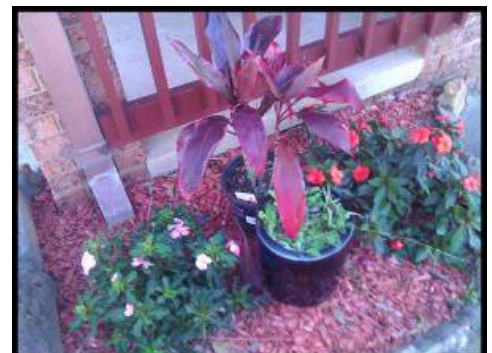
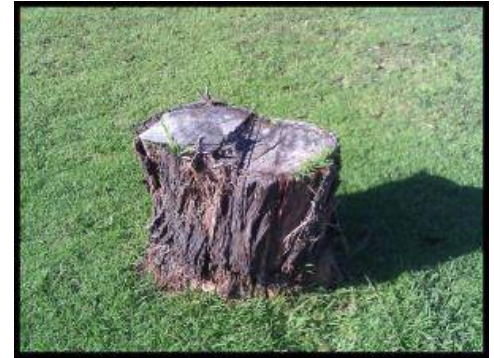
Description The hot water system overflow is discharging moisture adjacent to the structure. We recommend the overflow be situated over a drain. Tree stumps should be removed.

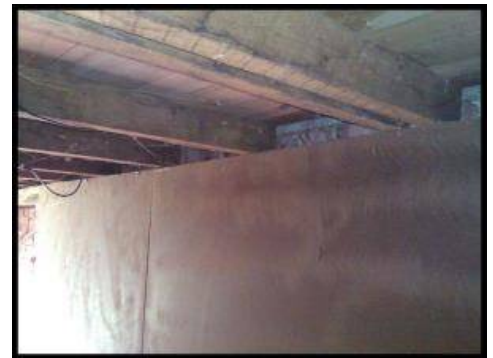
Inspection was restricted in or below the following locations and or areas: Toilet. Bedroom two. Bedroom three. Some or all of the original timbers have been covered by lining material.

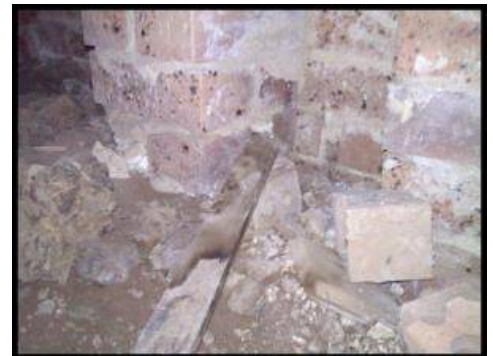
We recommend the removal of loose timbers from the underfloor area as these predispose the property to termite attack.

Below The Following Location Or Area; Isolated areas throughout.
