Visual Property Inspection Report

Complies with Australian Standard AS 4349.1-2007

Sample Street

VISUAL BUILDING INSPECTION REPORT

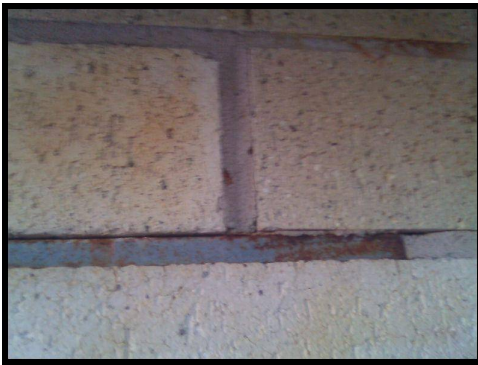
Lintel type/s noted: Mild steel. Rust is evident to some steel lintels. Rusty areas should be treated to prevent further deterioration.

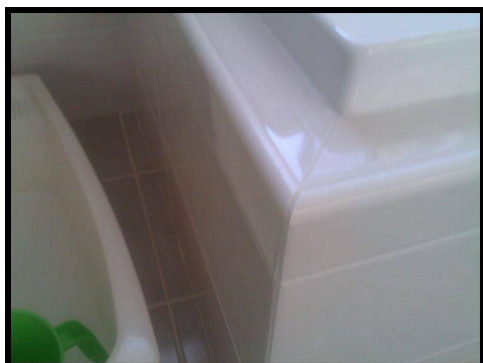
The quality of the tiling is poor to the bath hob area. Rectification will be required.

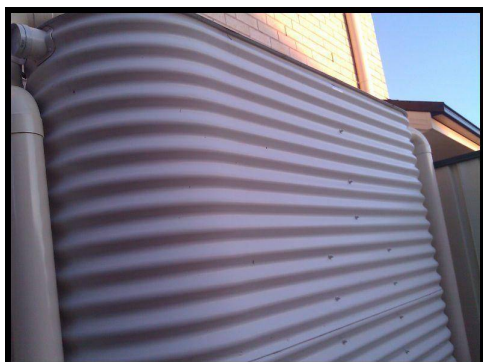
Inspection to sections of the exterior was restricted due to the stored goods/water tank. These goods must be removed to enable a more complete report to be submitted. Inspection was limited in the following locations and or areas: Eastern elevation.

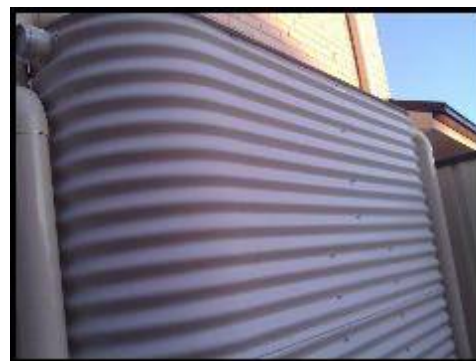
Restrictions: Inspection to sections of the exterior was restricted due to the stored goods/water tank. These goods must be removed to enable a more complete report to be submitted. Inspection was limited in the following locations and or areas: Eastern elevation.

Defects and or damage requiring rectification may not be apparent to the inspector due to this restriction. Recommend access be gained.
